URGENT FIELD SAFETY NOTICE – Product Recall

SPII Model Lubinus, Hip Prosthesis Stem XL Neck, cemented, L= 150 mm, left L3, large, CCD 126°, CoCrMo, anatomical, Taper 12/14 [Article Ref 127-767/26]

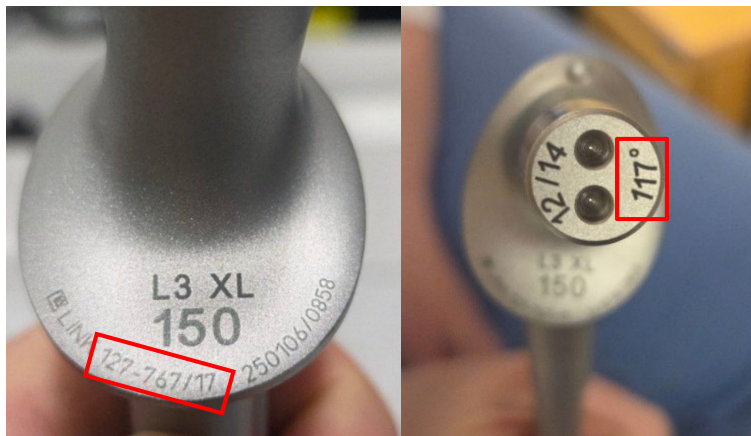
Figure 1: The device laser markings of the affected SPII Hip Stem 127-767/26 show the incorrect Article Ref and CCD-Angle.

Incorrect

CCD-Angle: 117°

Article Ref: 127-767/17

Correct

CCD-Angle: 126°

Article Ref: 127-767/26

Due to a complaint, it has come to our attention that the device laser markings of one production order of SPII Model Lubinus Hip Stems with the article Ref 127-767/26 show the incorrect Article Ref 127-767/17 and the wrong CCD-Angle 117°.

Should you have any of the affected product in your inventory, please send the products back to Waldemar Link GmbH & Co. KG.

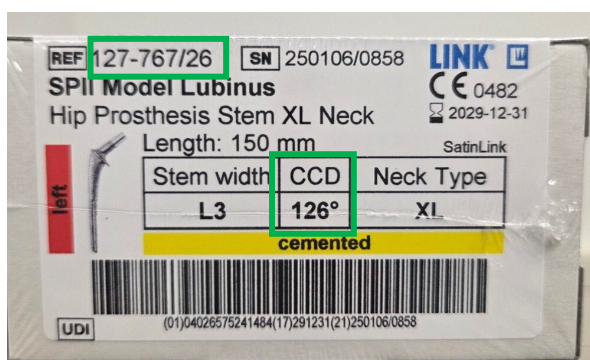
Figure 2: The labels of the affected SPII Hip Stem 127-767/26 show the correct Article Ref and CCD-Angle.

All information on the labels are correct

CCD-Angle: 126°

Article Ref: 127-767/26

The information on the main label and patient label is correct. The incorrect laser marking is visible on the item and could be detected during surgery prior implantation.
