Urgent Safety Notice

Precautionary replacement of motors on older treatment tables

Re: THERA treatment tables from FREI AG

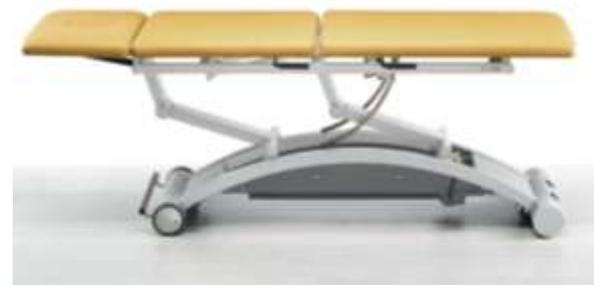
THERA treatment tables with article numbers:

Standard: 8.5200.03 ; 8.5200.04 ; 8.5200.10
Universal: 8.5205.00 ; 8.5205.03 ; 8.5205.04 ; 8.5205.10
Manual: 8.5210.00 ; 8.5210.03 ; 8.5210.04 ; 8.5210.10
pro: 8.5207.04 ; 8.5207.05 ; 8.5212.04 ; 8.5212.05
Edition: 8.5206.03 ; 8.5206.04 ; 8.5206.05 ; 8.5211.03
Vojta: 8.5215.00 ; 8.5215.03 ; 8.5215.04

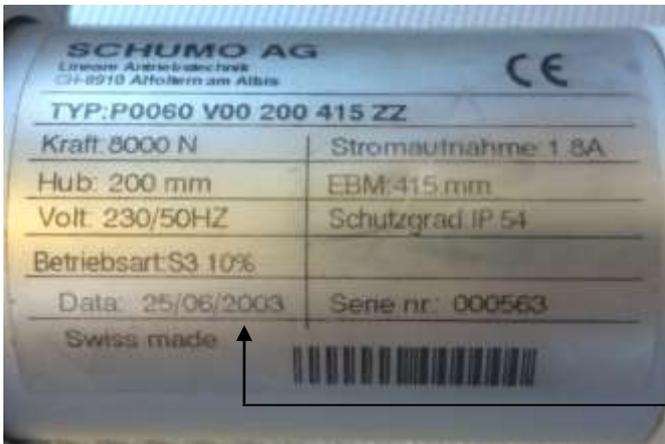
Example of a motor type plate:

Check the year of manufacture of all adjustment motors on your treatment tables. Motors older than 10 years should be replaced as a precaution. The age of the motor is indicated on the type plate of the motor or on the treatment table.

Year of manufacture

If this inspection fails or cannot be carried out, please stop using these treatment tables and contact FREI AG. We are happy to assist you with any questions regarding this measure. The age of the motors and thereby the replacement interval must be checked in the course of the recurring safety inspection.
