# URGENT MEDICAL DEVICE CORRECTION MANDATORY SOFTWARE UPDATE IOLMASTER 500

#### IMMEDIATE ACTION REQUIRED

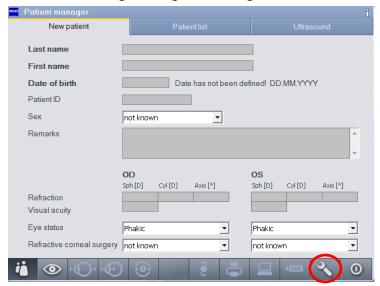
These versions of software have a software defect which can result in incorrect IOL calculations being presented on screen and in a printout/export in rare cases when a specific non-standard workflow is used.

- Insert the USB flash drive containing the update file.
   Note: Prior to installation all other flash drives must be removed from the IOLMaster. During installation only the USB flash drive with the new software may be plugged in.
- 2) Under "Settings", navigate to "Program".
