Urgent Field Safety Notice

Affinity Fusion™ Oxygenator Temperature Monitoring Adapter

Medtronic Reference: FA1302

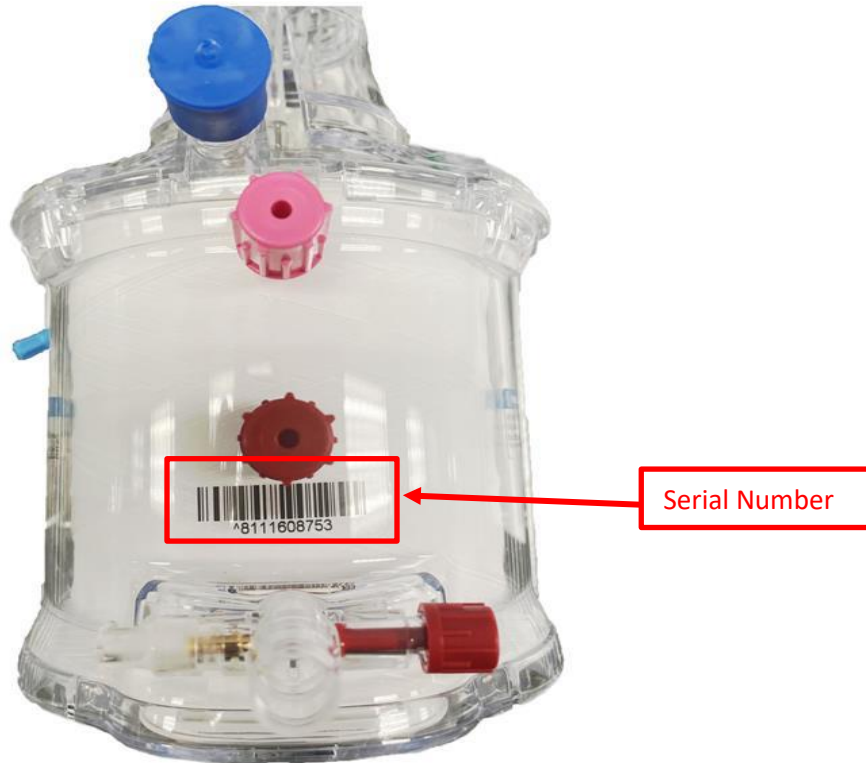
Image 2 - SN location on the Affinity Fusion Oxygenator

At time of set up, locate the serial number on the affected product by referring to the image below.
