URGENT Field Safety Notice

MR systems terminal connections in the general Mains Distribution Unit (g-MDU) may produce a Thermal Event

19-April-2024

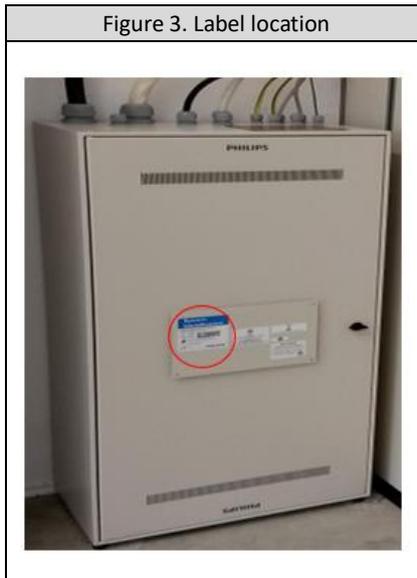
Figure 3. Label location

- Enter the Technical Room
- Locate the Mains Distribution Unit (gMDU)
- The label is located on the front door of the gMDU, (see Figure 2)
