Urgent Field Safety Notice

Reference Number: 1170852 Vasoview Hemopro 2 Endoscopic Vessel Harvesting System (VH-4000 and VH-4001)

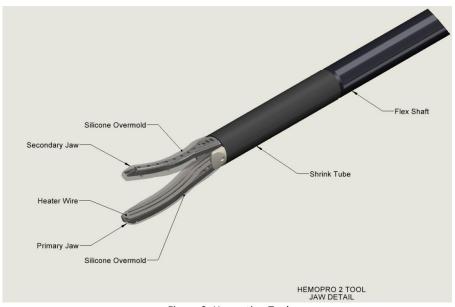
Figure 3: Harvesting Tool

- 1. A bent or detached heater wire
- 2. Silicone peeling or detaching from the Jaws of the Harvesting Tool

MCV/Getinge has confirmed 126 complaints that are related to silicone peeling and/or detaching from the Jaws of the Harvesting Tool during use between November 1, 2022, and October 31, 2024. There have been three (3) serious injuries related to this issue. Two (2) of the three (3) serious injuries required an additional incision during the procedure, and one (1) resulted in a vessel burn. There were no reports of life-threatening or permanent injury.

- 2. Consider the following to mitigate the risks:
 - Inspect the device prior to use for any signs of damage including silicone peeling away from the jaws.

- Check the outer surface of the device for rough surfaces, sharp edges, or unusual protrusions that may be a hazard.
 - Monitor the device during use for silicone peeling away from the jaws.

- Inspect the device after use for missing or damaged parts.
 - If, at any time of use, the user notices missing or damaged parts or peeling of silicone, device use should be terminated, and any fragmented components should be located and removed from the patient.
