Date: 27-Jun-2025

Urgent Field Safety Notice
3mensio Workstation (Vascular – Fenestrated)
Version (10.6, 10.6 SP1, 10.6 SP2, 10.6 SP3, 10.6 SP4, 10.7, 10.7 SP1)

The purpose of this letter is to advise you that Pie Medical Imaging is issuing an urgent Field Safety Notice regarding the clock position visualization in the fenestration diagram in 3mensio Workstation 10.6 (Vascular – Fenestrated layout) or 3mensio Workstation 10.7 (Vascular – Fenestrated layout).

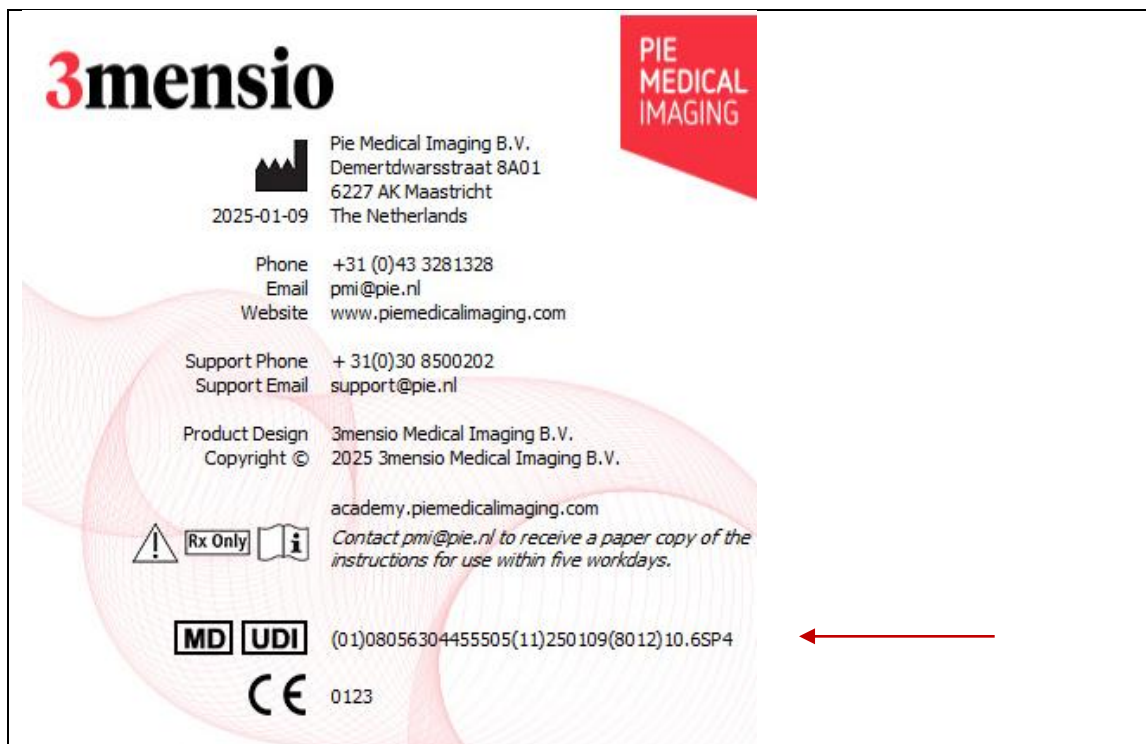
The UDI can be found in the About Box, which can be found as follows:

1. Open application
2. Click on the '?' in the top left corner
3. Click on 'About'
