**NEW****URGENT: FIELD SAFETY NOTICE – MMS-25-5342****BD Alaris™ Syringe Pumps****REF:** See Table 1 and 2 **Serial Numbers:** See webpage link**Type of Action:** Field Work**Attention: Clinical Personnel, Risk Managers, Biomedical Personnel, Purchasing Managers**

BD is conducting a Field Safety Corrective Action for specific serial numbers of BD Alaris™ Syringe Pumps and specific spare kits. According to our distribution records your organisation may have received the impacted product listed in Table 1 and Table 2.

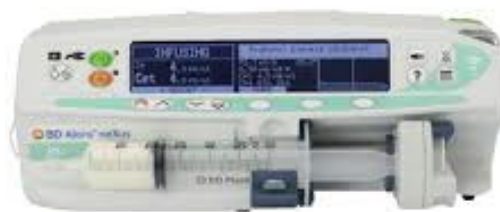
**Picture 1: BD Alaris™ Syringe Pump**

Based on customer feedback, BD has identified that a potential manufacturing defect affecting certain BD Alaris™ Syringe Pumps related to keypad functionality. It has been observed that specific lots of the keypad components may exhibit unintended behaviour impacting the “On/Off”, “Hold” and “Run” keys.

- Organize for the affected Alaris™ Syringe pumps serial numbers to be made available to BD, your Biomedical Engineering team or to your Service Organisation as applicable for keypad replacements.
