Urgent Field Safety Notice

Potential for Suspension of Dynamic Sensing Algorithm

Aurora EV-ICD™ (DVEA3E4) UDI: 00763000368463, Clinical EV-ICD (DVEX3E4) <00763000217891

Medtronic Reference: FA1511

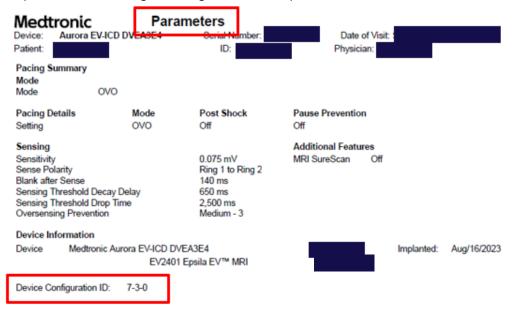
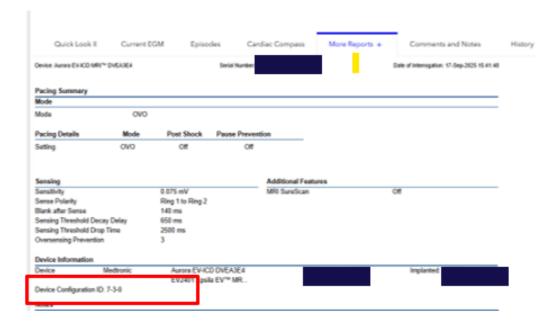
The Device Configuration ID can be found under the "Device Information" section of the SmartSync Parameters Report, or for CareLink patients, under the *Transmission Details* page by selecting <More Reports > 'Parameters.' The Configuration ID is also included on the CareLink patient report that is available upon request. Note that devices that have successfully received the update will not be removed from the serial number lookup on the Medtronic Product Performance Report Website and will remain listed as in scope, therefore checking the configuration ID is required.

- Clinical device (DVEX3E4) configuration ID is 6-1-0 or greater
- Aurora EV-ICD (DVEA3E4) is 7-3-0 or greater

To identify if a device on your shelf was manufactured with the update, look for version 02 or higher listed underneath the barcode:
