**FIELD SAFETY NOTICE*****Arjo Carevo shower trolley***

| <b>Product Issue:</b> | Carevo shower trolley torsion spring defect that may increase likelihood of incomplete handle locking potentially contributing to side support opening. |
| <b>Field Safety/Correction Notice:</b> | FSN_2980188-3 |

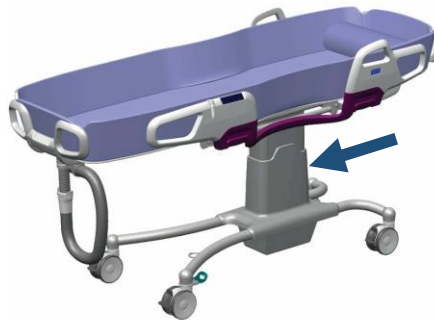
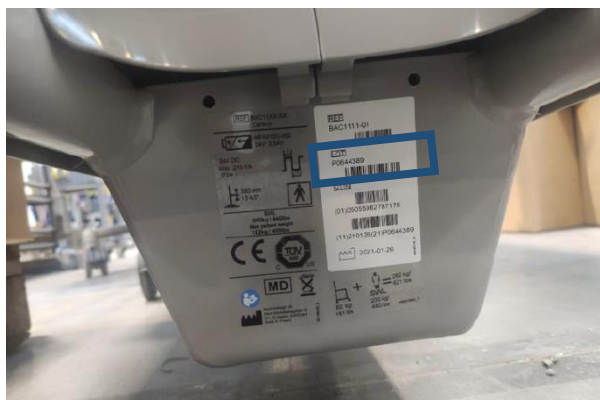
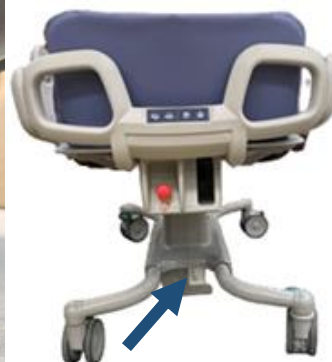
To determine whether the Carevo shower trolley in your facility is affected, please check its serial number. The serial number label is located on the lower frame (chassis) of the shower trolley, between the leg, from the head-end side of the device, as shown in the reference photo below. Please compare the serial number on your device with the list of affected units provided by your local Arjo representative along with this letter.
