**SUBJECT: Urgent Field Safety Notice. S-ICD programmer software version 4.04 addresses two previous Field Safety Notices (ref. 10000038388 and ref. 92127890)**

**S-ICD Behaviors Addressed By Version 4.04 Software**

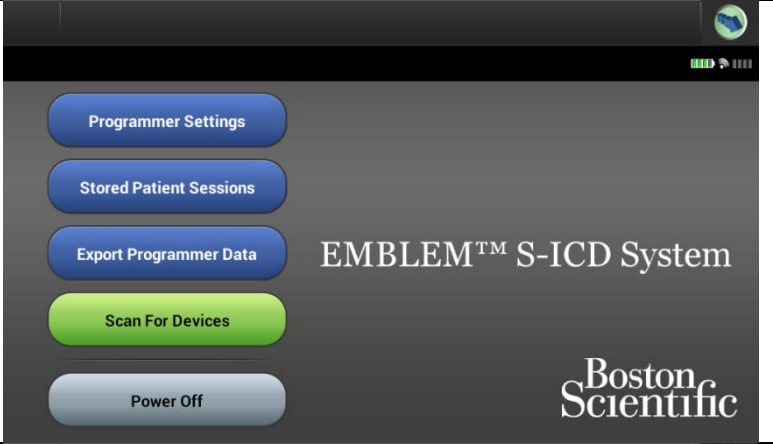
<p>1. Vælg "Programmer Settings"</p>

Sådan identificeres softwareversionen på en S-ICD programmer model 3200

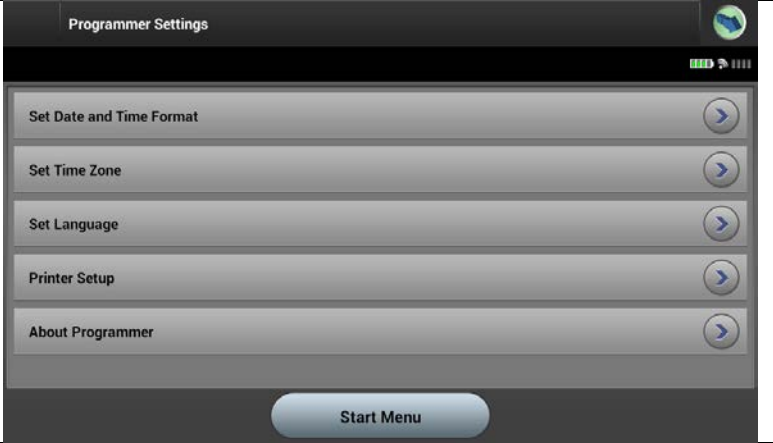
<p>2. Vælg "About Programmer"</p>

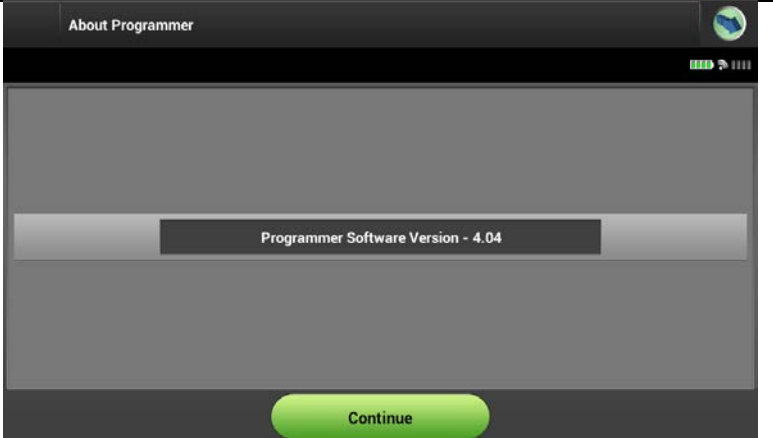
<p>3. Software, der er version 4.04 eller højere, afhjælper dette problem for S-ICD'er</p>
