Subject: Pacemakers – Technical programming information on Minute Ventilation Sensor.
Ref.: 92186345-FA

Product name	Models
VALITUDE™ CRT-P	U125, U128
ACCOLADE™ Pacemakers	L300, L301, L310, L311, L321, L331
ESSENTIO™ Pacemakers	L100, L101, L110, L111, L121, L131
VISIONIST™ CRT-P	U225, U226, U228
PROONENT™ Pacemakers	L200, L201, L209, L210, L211, L221, L231
ALTRUA™ 2 Pacemakers	S701, S702, S722

Appendix B: Programming instructions supporting recommendations included in the December 2017 MV Product Advisory

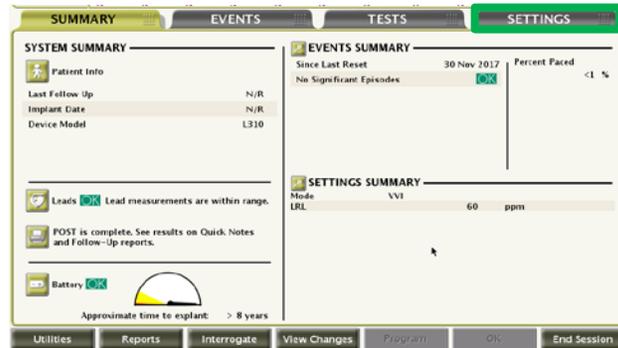
1. On the Summary page, select

"Settings" Tab

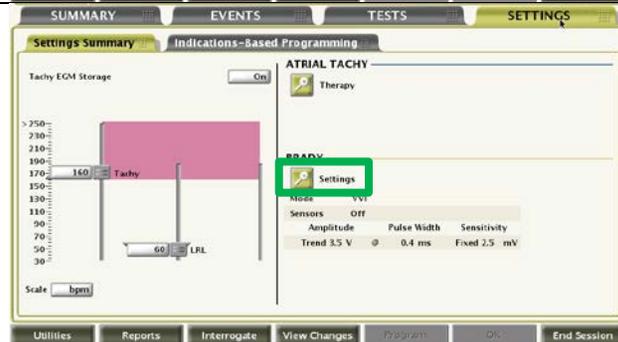
2. On Settings Summary Tab, in the Brady section select

"Settings" button

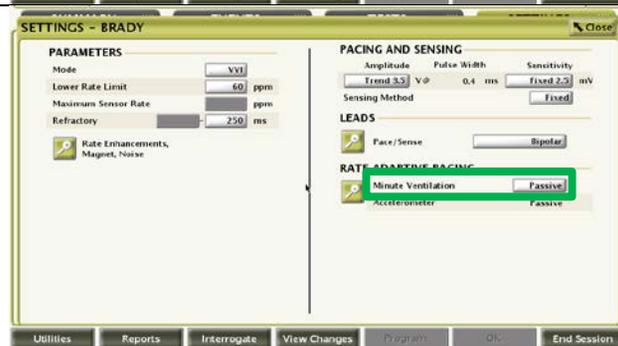
3. On Settings – Brady page, in the Rate Adaptive Pacing section, review the Minute Ventilation programmed value.

If the value is "Passive" or "ON" the MV sensor is enabled.

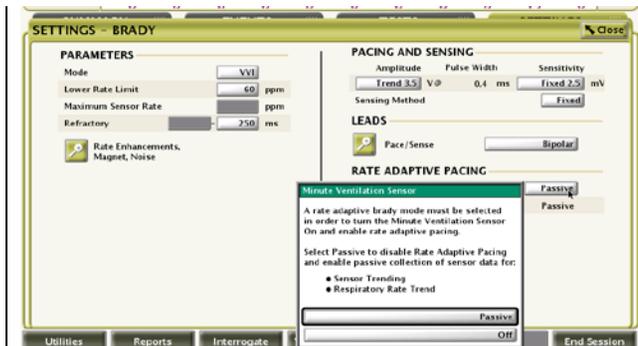
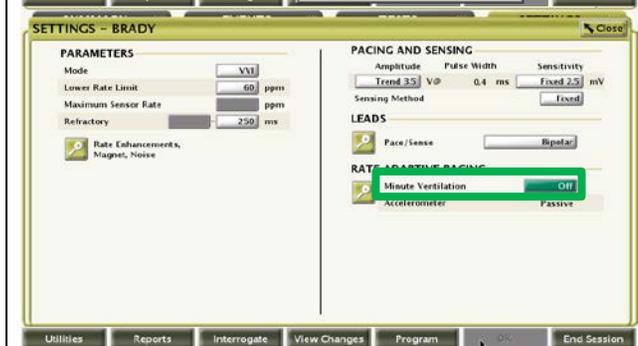
4. To eliminate the potential for oversensing the MV sensor signal, program the Minute Ventilation Sensor to "OFF"

- In accordance with the pacemaker manual, if MV sensor signal artifacts are observed on EGMs and leads are performing appropriately, consider programming the sensor to “OFF” to prevent oversensing.

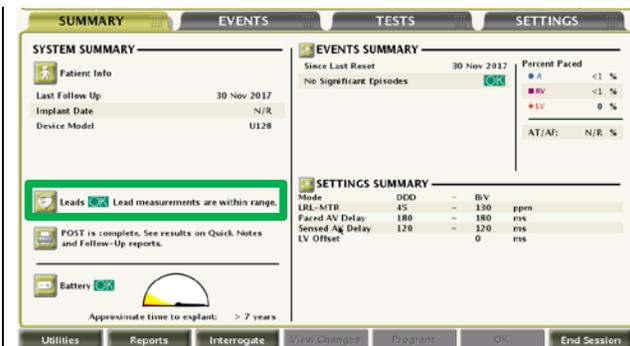
1. On the Summary page, select

“Leads” Button

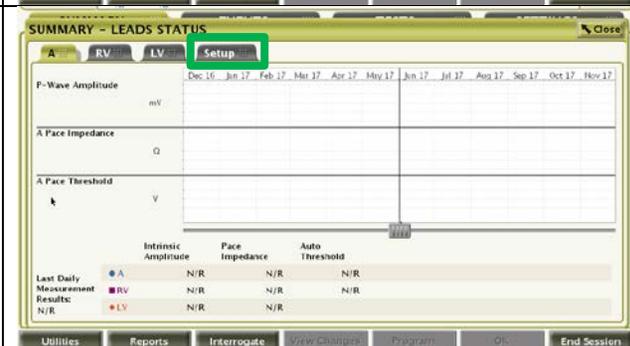
2. On the Summary – Leads Status page, select

“Setup” Tab

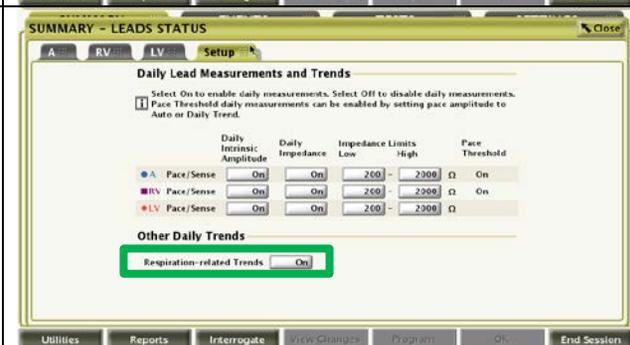
3. On the Summary – Leads Status page, in the Other Daily Trends section, review the Respiration-related Trends value.

If the value is “ON” the MV sensor is enabled.

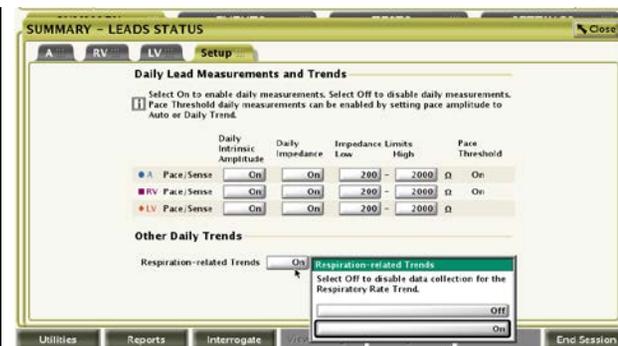
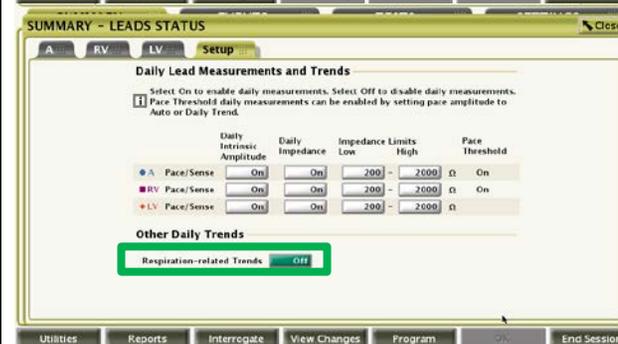
4. To eliminate the potential for oversensing the MV sensor signal, program the Respiration-related Trends value to “OFF”

For US configurations of affected CRT-PS, turn the MV Sensor “OFF” by disabling Respiratory Rate Trend.
