URGENT FIELD SAFETY NOTICE

Medtronic LINQ II Insertable Cardiac Monitoring Systems

Re: Brady, Pause & PVC Detections Disabled Following Partial Electrical Reset

APPENDIX A: Updating LINQ II ICM device software with SmartSync

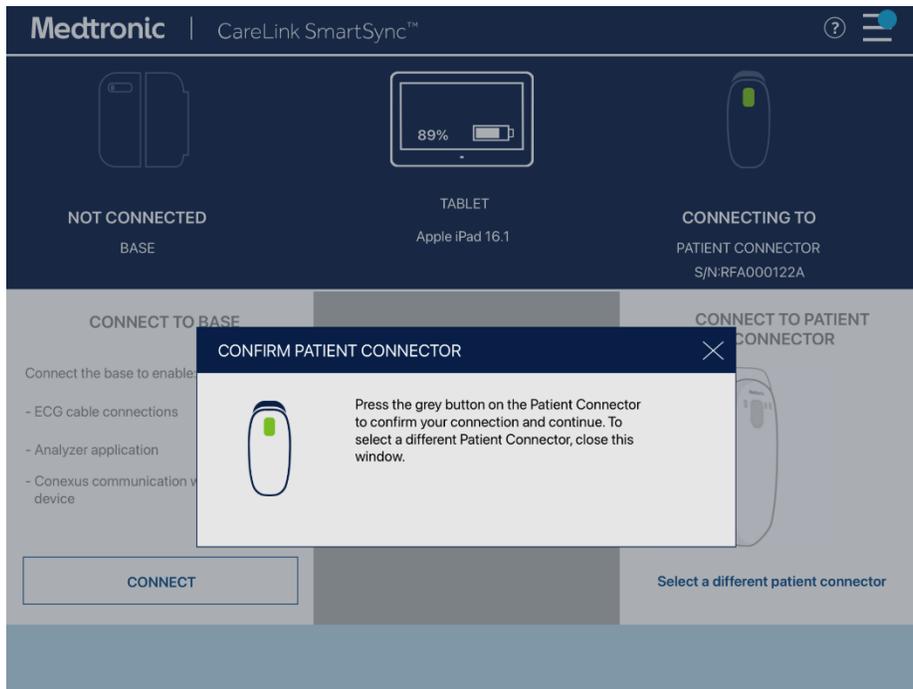
1. Confirm that the prerequisite SmartSync App version 3.15.3 or higher is installed, and all updates have been accepted. Refer to the latest Software Release Notes (August 2023 or later) for instructions. Note that SmartSync versions prior to 3.15.3 may result in a lock out - do not use prior SmartSync version with LINQ II.
2. PRESS the grey button on the Patient Connector to confirm your connection and continue.

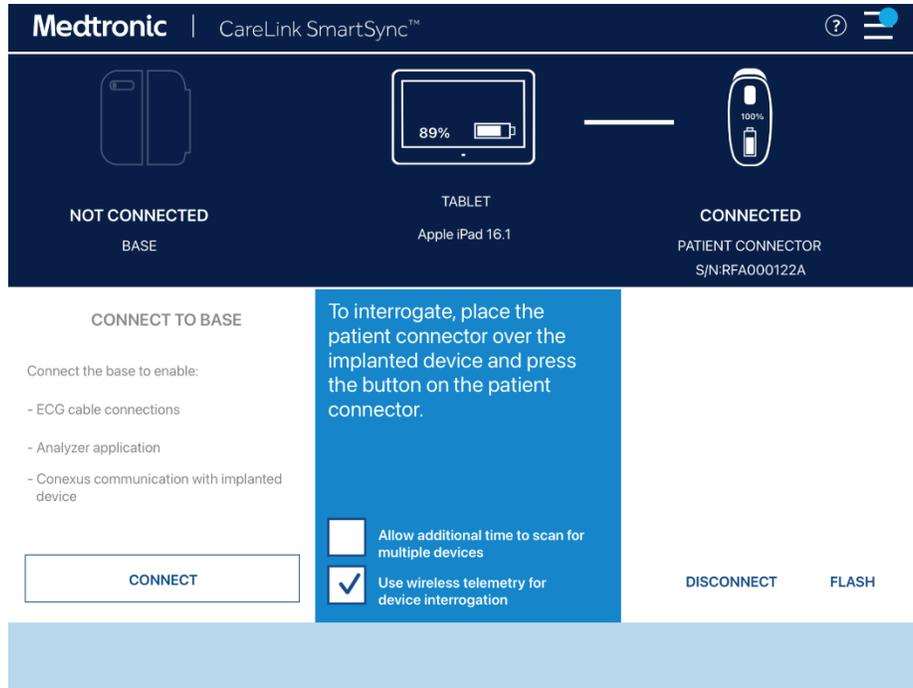
3. Once connection with the Patient Connector is established, SELECT "Use Wireless telemetry for device interrogation"

4. PLACE the patient connector on top of the LINQ II ICM.

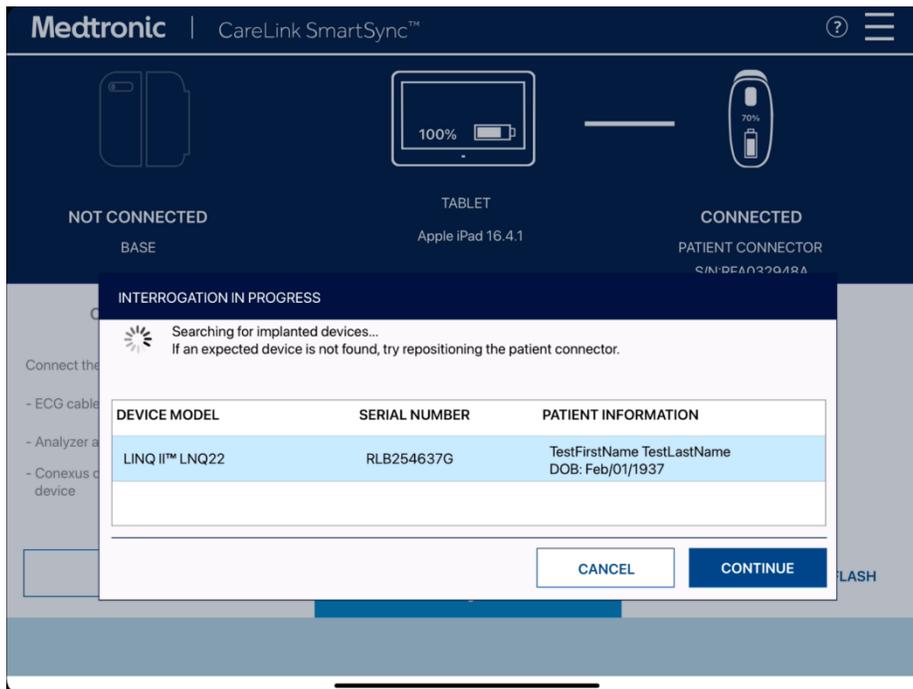
5. PRESS the grey button on the patient connector.

6. The app will start searching for the available LINQ II ICM.

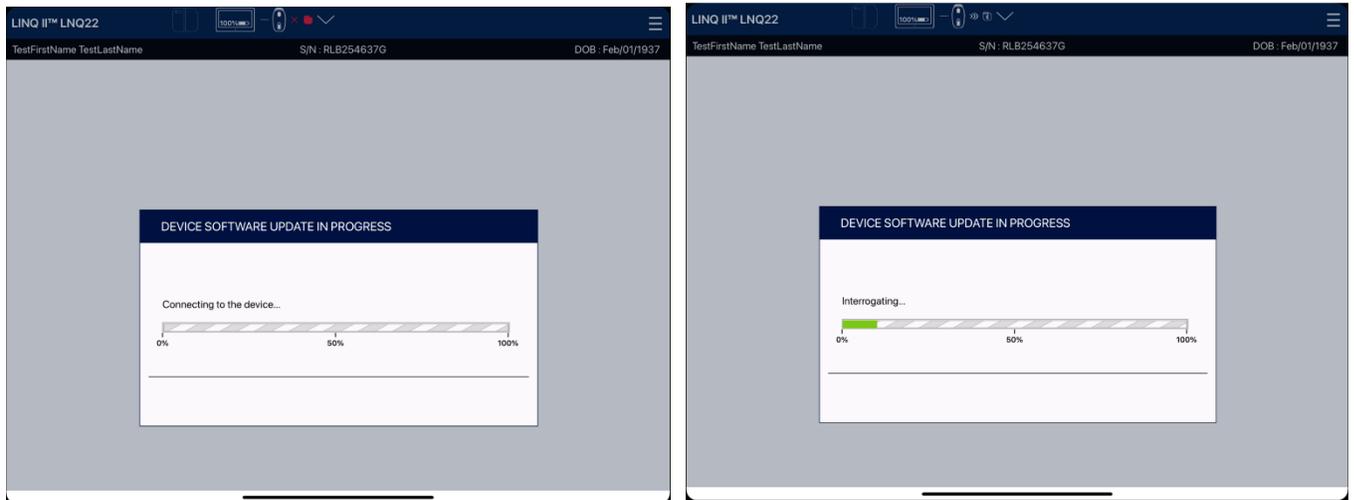
7. Once connected, the available LINQ II ICM will appear on the list. SELECT the LINQ II ICM from the list and SELECT "Continue" to pair.

- The software update will download to the LINQ II ICM, and the progress bar will indicate when the installation is complete.

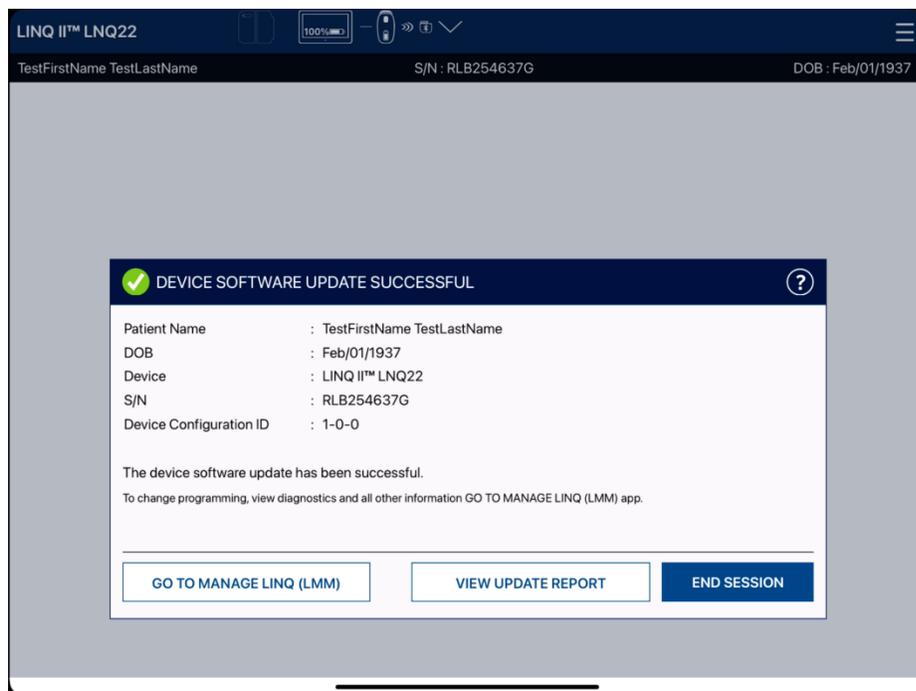
- A confirmation screen will appear indicating the successful download of the LINQ II device software (see image below).
