Urgent Field Safety Notice (FSN)

ARGUS 717V (REF 601268)

ARGUS 718V (REF 601349)

Therapy interruption / delay continuation of therapy

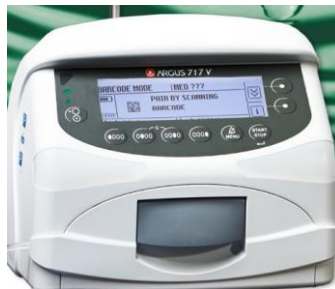
1 Information on Affected Devices	
1.1	<p>Device Type(s)</p> <p>ARGUS 717V Volumetric Pump (discontinued in 2017) and ARGUS 718V Volumetric Pump (discontinued in 2017)</p>
