# Urgent Field Safety Notice (FSN)

## ARGUS 717V (REF 601268)

**Therapy interruption / delay continuation of therapy**

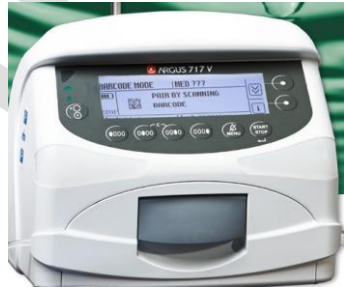
1 Information on Affected Devices	
1.1	<b>Device Type(s)</b>

ARGUS 717V Volumetric Pump (discontinued in 2017)
1.2	<b>Commercial name(s)</b> <b>ARGUS 717V</b>
1.3	<b>Primary clinical purpose of device(s)</b> The volumetric pump ARGUS 717V is purposed to deliver fluids and medications through any clinically accepted route of administration connected to a patient in a predefined way.
1.4	<b>Device Model/Catalogue/part number(s)</b> <b>REF 601268</b>
1.5	<b>Affected serial number range</b> All

<b>2 Reason for Field Safety Corrective Action (FSCA)</b>	
<b>2.1</b>	<b>Description of the product problem</b>
	<p>This problem involves the power board/mainboard female-on-board Micro-Match connector, the flat ribbon cable, and the Micro-Match male connector. If any of these components are defective, the connection between the mainboard and the power board can be compromised.</p> <p>The flat ribbon cable and connectors are particularly vulnerable to damage if the cable is pulled out by tugging on the wires during servicing.</p> <p>Additionally, during a Standard Safety Check (SSC) or repairs, if the back and front parts of the A71XV are opened too far without disconnecting the cable, it can create tension on the cable and connectors. This excessive mechanical stress can damage the crimping between the male connector and the cable, leading to a compromised connection between the mainboard and power board.</p> <p>In case this problem happens, the device could in rare cases unexpectedly shutdown and generates a technical error TE-8131 and/or TE-18028.</p>
