Urgent Field Safety Notice

Wireless Recharger Kits, Models RS6230 and RS7230 Used with Neurostimulator Models 977119 and B35300

Medtronic Reference: FA1441

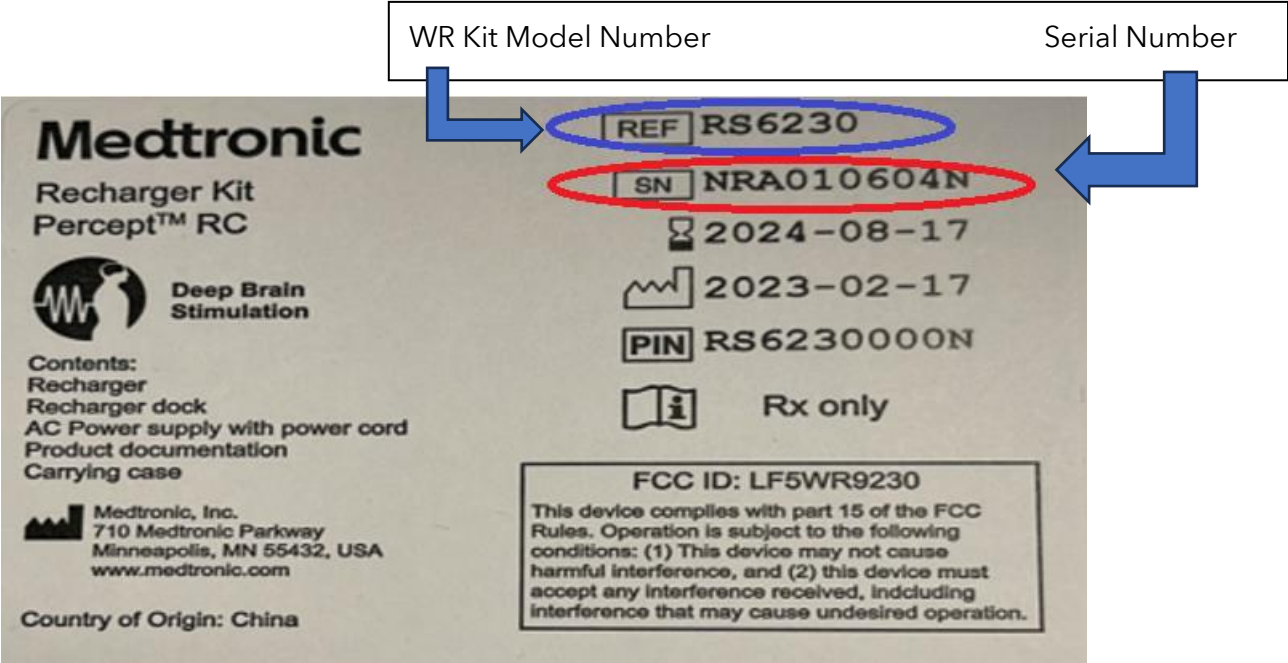
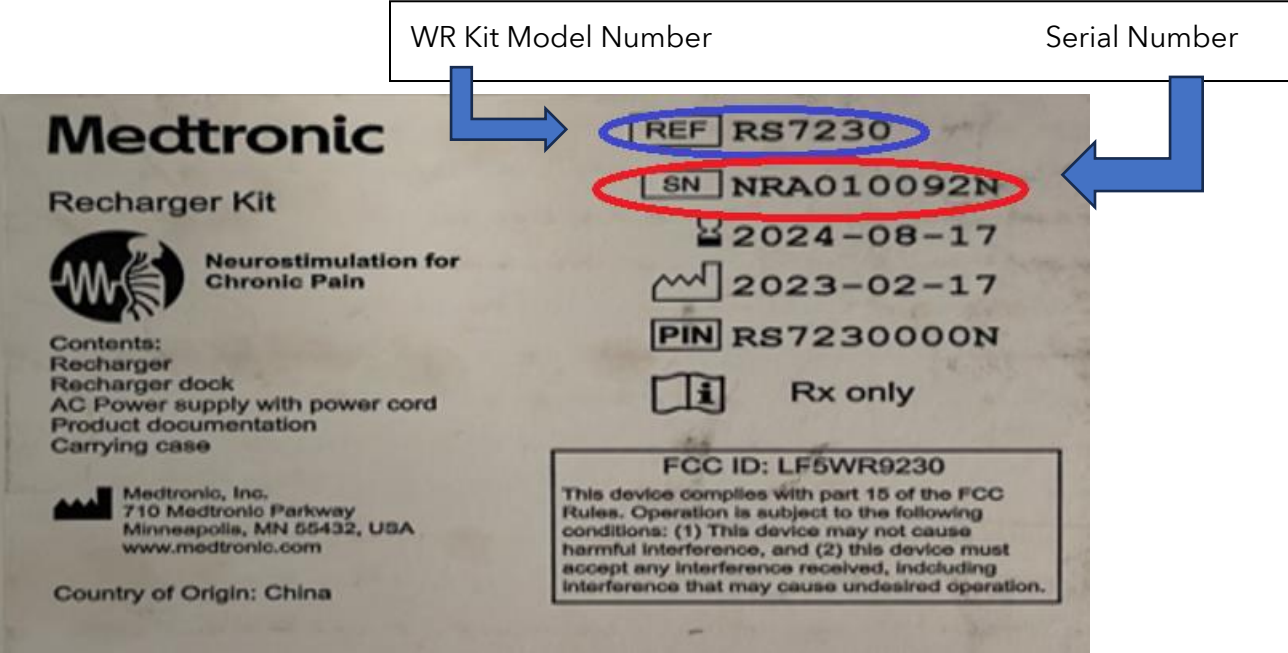
IDENTIFYING POTENTIALLY AFFECTED DEVICES

Locate product information on product labels in your inventory.

- Identify and quarantine all unused affected WR Kits. See attachment A for guidance on identifying potentially affected devices.
- Return all unused affected WR Kits and contact your Medtronic Representative to obtain a replacement WR Kit. Reach out to your Medtronic representative for any assistance.
- Share this notice with all those who need to be aware of this issue within or outside your organization or to any organization where the potentially affected product has been transferred or distributed and maintain a copy of this notice in your records.
