URGENT Field Safety Notification

Tempus Pro Monitor
Software Issues

28-APR-2025

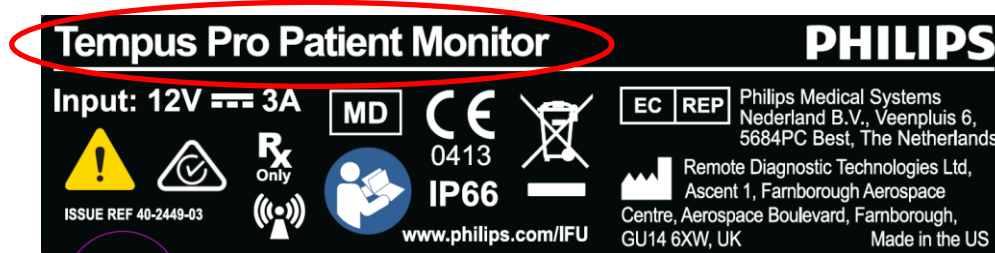
Tempus Pro Monitors are identified by a product label on the rear of the device, as well as a UDI label with the part number.
