**URGENT Field Safety Notice**

**Philips Azurion R3.0 Systems**

Potential loss of imaging (X-ray) functionality, and/or loss of motorized movement, and/or incorrect image content, and/or loss of data which may result in a delay or termination of procedure and/or procedural complications

05-DEC-2025

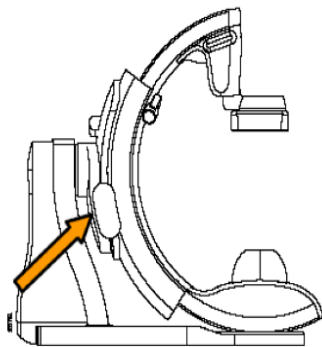
Figure 1- System Identification Label

The System Product Name and Model Number can be found on the System Identification Label located on the System stand (Figure 1). The software release version of the Philips Azurion systems can be identified during start-up (Figure 2).
