To all customers and users of Dräger monitor holders with AC2000 spring-loaded arm - ceiling-mounted installation -

## Important Safety Notice!!!

Dräger ceiling-mounted installations with monitor holder

- this problem concerns Ondal AC 2000 spring-loaded arms shipped up until Dec. 2006

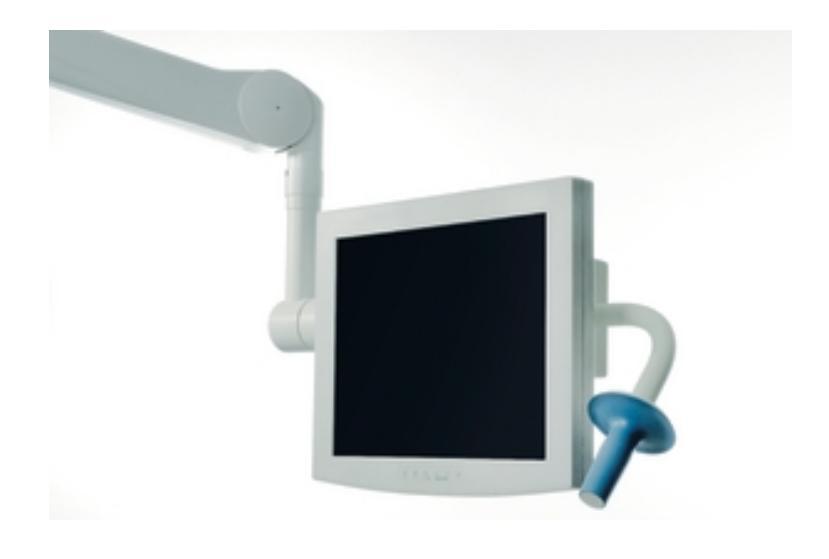
## Example of an installation affected:

Monitor with AC2000 spring-loaded arm

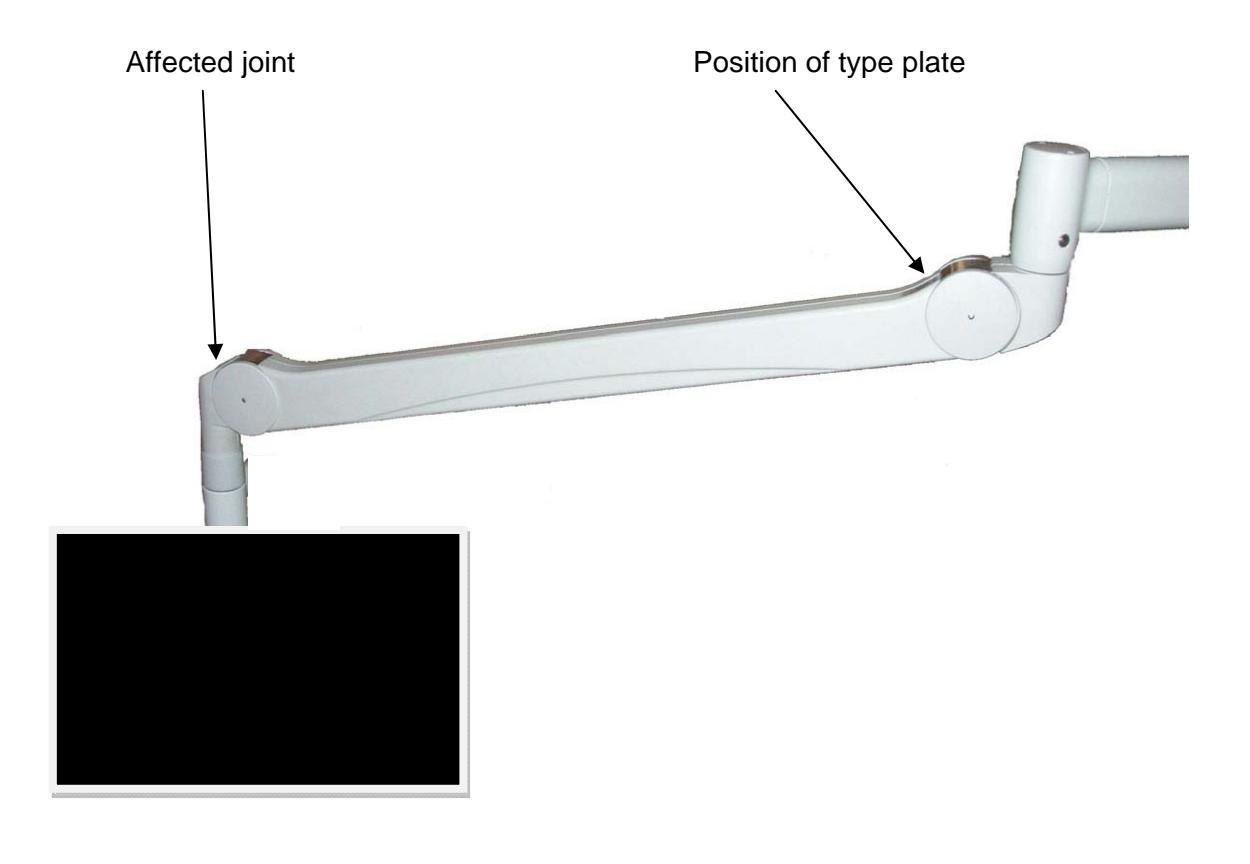
## Identification of installations and/or spring-loaded arms affected:

- Please use the attachment (figures, part and serial numbers) to check your ceilingmounted installations and identify the "AC2000" spring-loaded arms affected.
- Please inform your Dräger representative so that a free replacement of the spring-loaded arm can be arranged for you.
- Please inform your staff that monitors in the affected installations must not be positioned above people and that monitors must be moved with care (e.g. holding monitor in both hands) until the replacement has been carried out. In particular, monitors should not be positioned with considerable force the stress on the lower joint of the spring-loaded arm should be minimized.

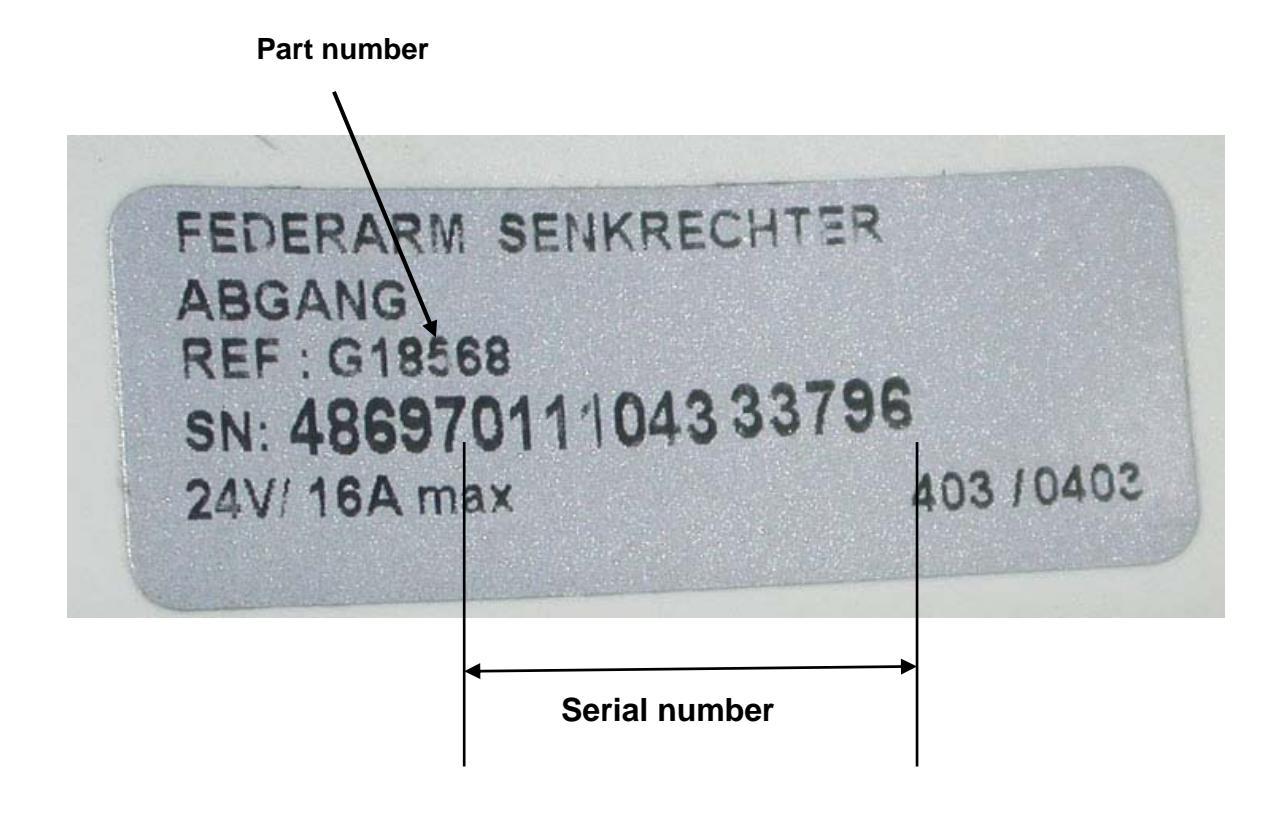
Verification of the spring-loaded arm part and serial numbers:

The manufacturer's serial number is located on the upper part of the spring-loaded arm near the **upper joint (in this example showing part number G18568)**:
