### **URGENT Field Safety Notice**

MR Systems: Patient support floor plate cage installation issue leading to potential for tipping

12-Mar-2024

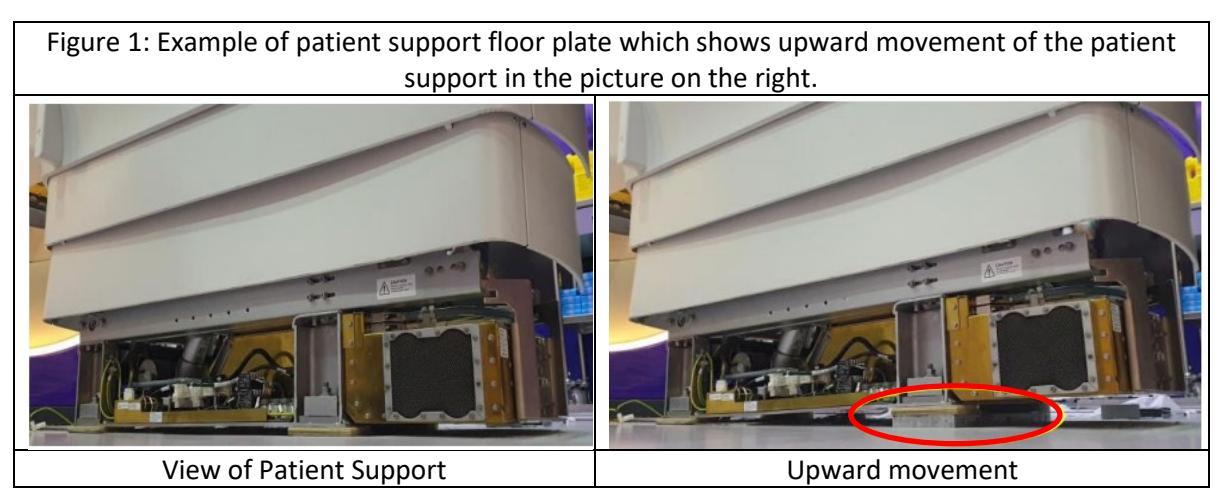
The patient support floor plates for MR systems may not have been anchored to the floor according to Philips requirements causing the patient support to become unstable with the potential for tipping (see Figure 1). This movement can inadvertently lead to harm to the patient and/or operator under certain circumstances.

- A. Customers can continue using the identified systems in accordance with the intended use.
- B. As a reminder: When using the system, follow section *Patient Support and Tabletop* in the Instructions For Use (IFU) provided with your system: *The safe working load as labeled on patient support and trolley is based on the sum of the maximum allowable patient weight and the mass of accessories and coils. The weights mentioned are equal to the safe working load* 
  - The maximum weight load allowed for horizontal and vertical movement of the tabletop on the patient support and the maximum allowed weight load of the table top on the FlexTrack in Table 1 below are taken from their respective IFU:

- C. If the patient's weight is at (or near) the maximum load mentioned above, take care that:
  - They do not sit on the end of the tabletop opposite the bore entrance.
  - From their seated position along the edge of the tabletop, they do not hop down from their sitting position while the support is at its highest position.

- D. If the patient support has any unexpected movement and / or becomes unstable (dislodged movement between the system and the floor), immediately stop use and contact your Philips service representative for interim support.
- E. Circulate this notice to all users of this device so that they are aware of the potential issue.
- F. Please display attached 'Advisory' with your system(s); ensure the notice is in a place likely to be seen/viewed by operators.
- G. Please complete and return the attached acknowledgment form to Philips MR promptly upon receipt and no later than 30 days from receipt via email to: pd.cnr@philips.com.

A Philips representative will contact you to schedule time for an FSE to visit your site to perform an inspection regarding the patient support stability. (Reference FCO 78100570).
