## URGENT: Field Safety Notice

Commercial Name of Product: Alcon 23G Non-Valved Trocar Cannula and Infusion Cannula

Identifier: JP.T12.8REC.001

Type of Action: Advisory Notice on Interaction Between Alcon 23G Non-Valved Trocar Cannula and Infusion Cannula

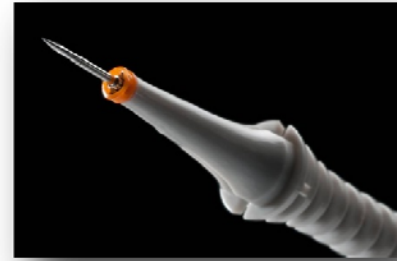
Alcon confirmed complaints for the 23G non-valved trocar cannula and infusion cannula related to a loose fit between the non-valved trocar cannula and infusion cannula. This loose fit may cause the infusion cannula to dislodge from the trocar cannula during the surgical procedure, which may eliminate the necessary infusion to the eye required to maintain adequate pressure while operating.

- 1) Upon opening the previously identified impacted product, Health Care Professionals should **use a single valved trocar cannula (grey handle) for the INFUSION CANNULA ONLY, in PLACE OF the non-valved trocar cannula (black handle).**
- 2) Discard the unused non-valved trocar cannula (black handle).
