**URGENT MEDICAL DEVICE RECALL NOTICE**  
December 11<sup>th</sup>, 2012

**PT Hybrid Glenoid Post**  
**Part Numbers: PT-113950**  
**Lot Numbers: specific**

## **FIELD SAFETY CORRECTIVE ACTION**

**Ref: PT Hybrid Glenoid Post PT-113950 Lot Number 984790**

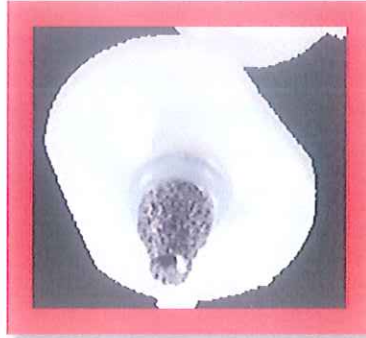
This notification is to inform you of an Urgent Medical Device Recall initiated by Biomet Orthopedics ("Biomet") which involves **Part Number PT-113950 PT Hybrid Glenoid Post**, an implant that has been consigned and/or invoiced to your account. Biomet has initiated this action following an investigation which identified that the male thread of the post may be oversized. This oversized condition can vary in degree and may lead to the following three events:

- 1) If the PT Hybrid Glenoid Post is not fully seated into the Hybrid Base and the implant construct is implanted, then a gap of 1-3 mm will be present.
- 2) If excessive torque is applied to assemble the post into the base, the PT Hybrid Glenoid Post drive tip could break off.
- 3) The PT Hybrid Glenoid Post may not thread at all into the Hybrid Glenoid Base, which would prevent assembly of the two implant components.

- 1) A PT Hybrid Glenoid Post that is implanted with a gap of 1-3mm present may lead to premature failure or fracture of the post-base assembly, which could potentially require a revision surgery.
- 2) If the drive tip breaks off or if the post does not thread at all onto the base, then another implant would need to be used, which could lead to a delay in surgery of less than 30 minutes.

On behalf of the manufacturer, Biomet Orthopedics LLC is issuing this FIELD SAFETY CORRECTIVE ACTION to make users aware of this issue and request them to immediately return the affected PT Hybrid Glenoid Post to their local Biomet distributor. Further details are in the attached FIELD SAFETY CORRECTIVE ACTION NOTICE.
