## **URGENT MEDICAL DEVICE RECALL NOTIFICATION**

### **RE: STRYKER SMARTLIFE® ASEPTIC HOUSINGS**

October 8, 2014

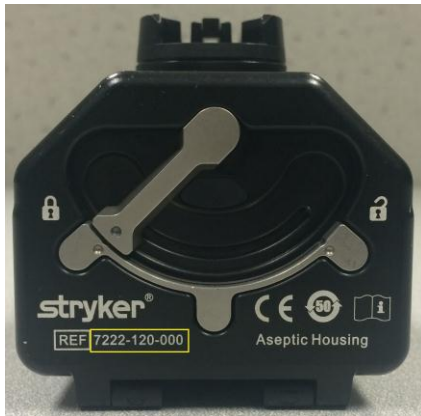
**Photo 2:** Product Number is on the exterior of the lid in white. The *yellow box* does not exist on the product. It has been added to the photo to identify the location.

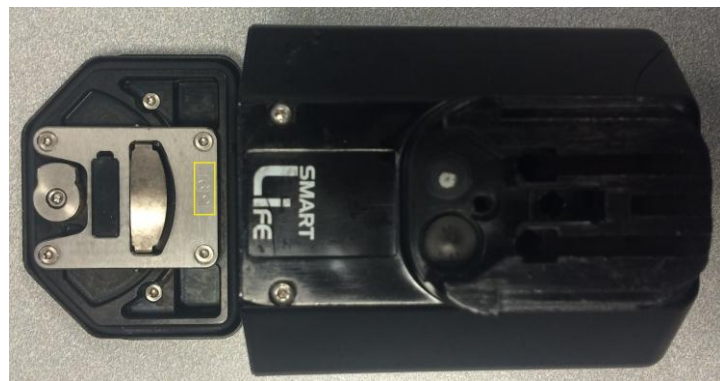
**Photo 3:** Lot Number is etched on the interior of the lid. The *yellow box* does not exist on the product. It has been added to the photo to identify the location.
