Medical Device – Advisory Notice

Name of the product	Reference	Batch
OPTIGUN RATCHET	4195	0101296012
OPTIGUN RATCHET US	419500	0101296012

This Advisory Notice is to inform you of an issue Biomet France is facing with the pin which maintains the knob button in relation to the following products :

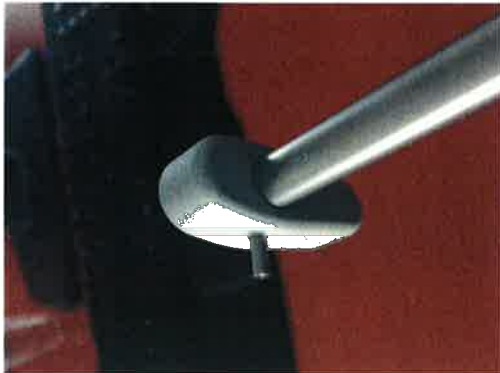
Picture 1

Biomet France has initiated this action after having receiving a number of complaints indicating that the pin which maintains the knob button felt down and the knob button was disconnected from the axis of the Optigun (see pictures below).

The investigation performed by Biomet France revealed that the diameter of some Optiguns rack holes in which the pin is inserted is out of specification.

Biomet France ask you to check the maintaining of the pin before using of the Optigun with applying light pressure on pin. If you identified any item with defective pin from the affected item/lot combination, please contact your local Biomet Distributor as soon as possible for replacement.

In the remote event of the loss of the pin occurred during surgery, care should be taken that the pin does not fall into patient body.
