ZIMMER BIOMET

Subject: **URGENT FIELD SAFETY NOTICE - REMOVAL**

FSN/FSCA title: **Several Hip, Knee and Shoulder products with a high polished surface packaged in LDPE (Low Density Polyethylene) pouches**

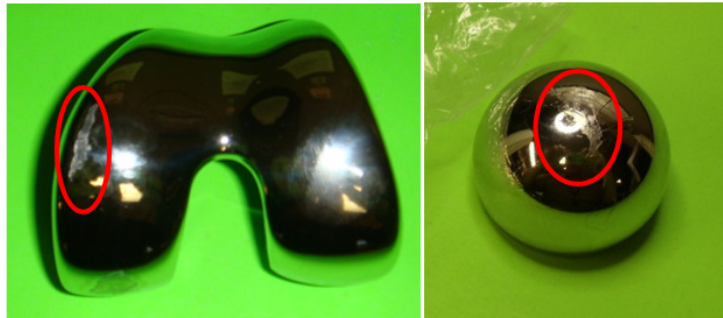
Representative pictures of implants subject to LDPE bag adhesion, are shown below.

Knee Femoral Component

Bipolar Cup

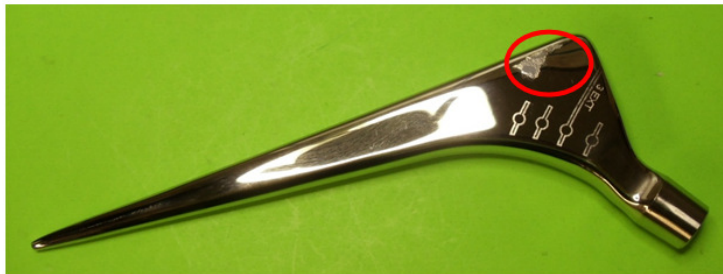
CPT® Stem
