Field safety notice

Concerned products: Overhead lift Altair, Roomer S

Date: 8th of July 2016

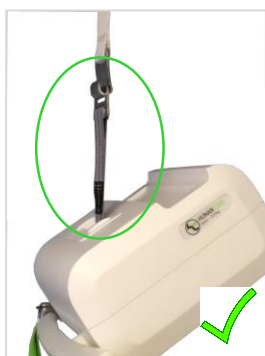
Recommended use. Lift belt not fully retracted with load.

- Secure that the monthly inspection of the lift belt takes place.
- Pay extra attention to any wear of the lift belt seams.
- Inform Human Care if any unexpected wear of the lift belt is discovered.
- Avoid operating the lift unit to its highest level loaded with 2-point suspension.
- Confirm back to Human Care by signing this document that this message has been received and understood.

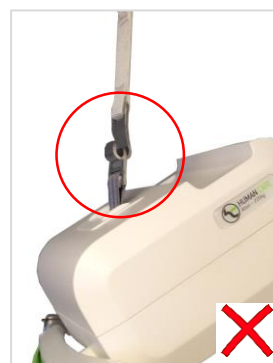
It has come to our attention that some customer use 2-point suspension together with long distance straps attached between the lift unit and the rail system. This can create a user pattern where the lift unit is being operated to its highest level with the lift unit tilted due to load. This might cause unexpected wearing of the lift belt and we therefore do not recommend to operate the lift to its highest level (belt roll fully retracted) when loaded with a 2-point suspension.

Not recommended use. Lift belt fully retracted with load.

Human Care will send out a replacement part of the lift during fall 2016. This change will prevent the unexpected wearing of the lift belt. More information about the replacement part will follow during the fall.
