URGENT FIELD SAFETY NOTICE

Product Name: **Alaris™ GS, GH, CC, TIVA, PK, Enteral Syringe Pump**

Product Name: **Asena™ GS, GH, CC, TIVA, PK Syringe Pumps**

FSCA Identifier: **RA-2017-02-02**

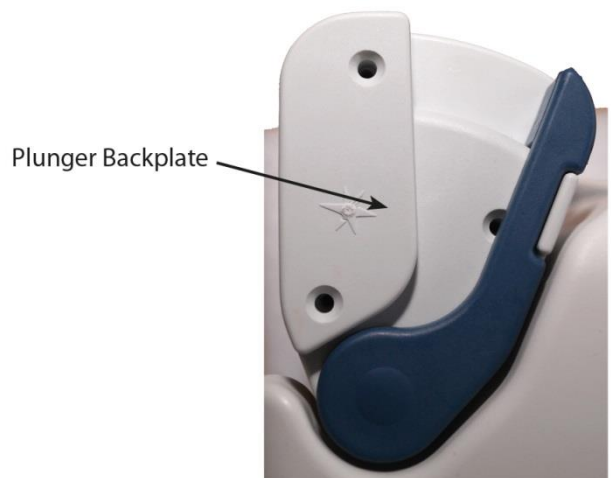
2. Visually inspect the interior of the plunger, replace any broken components.
See Technical Service Manual *Chapter 6 Corrective Maintenance* for further details.

3. Remove three screws holding plunger backplate.
