Urgent Safety Notice

Precautionary replacement of motors on older treatment tables

Re: ARCUS treatment tables from FREI AG

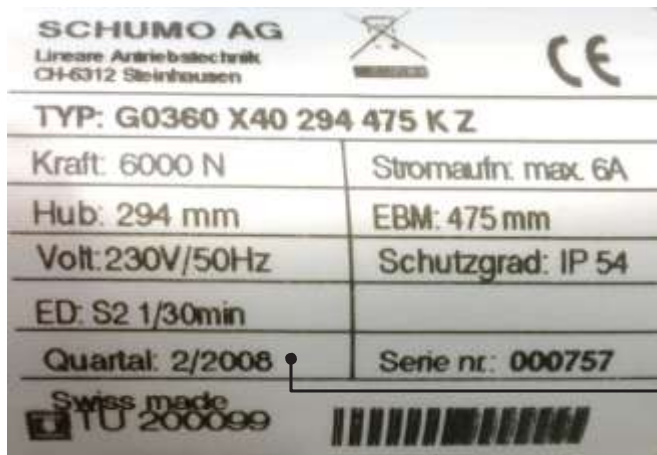
Example of a motor type plate:

Check the year of manufacture of all adjustment motors on your treatment tables. Motors older than 10 years should be replaced as a precaution. The age of the motor is indicated on the type plate of the motor or on the treatment table.

Year of
manufac
ture

If this inspection fails or cannot be carried out, please stop using these treatment tables and contact FREI AG. We are happy to assist you with any questions regarding this measure. The age of the motors and thereby the replacement interval must be checked in the course of the recurring safety inspection.
