Important Safety Notice!!!

Possible hose short circuit

Only disposable breathing circuits on the attached list are affected

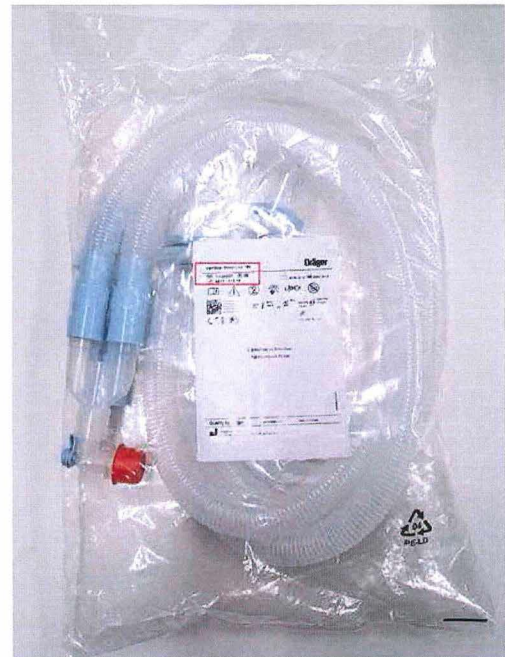
position of material number

According to our records, it is possible that breathing circuits that may be affected, i.e. that may have been incorrectly pre-assembled, were shipped to you during the past two years. We attach a list of material numbers that may be affected. The material numbers of the breathing circuits can be found on the respective packaging (see photo).
