**Urgent: Field Safety Notice – COM21KLA.008**  
**Batch KIT IRIS**  
**Type of Action: Advisory**

It concerns:	
Name:	<b>Batch KIT IRIS</b>
Part-number:	<b>0246050022</b>
Batch number:	<b>Unknown</b> at the time of writing this notification

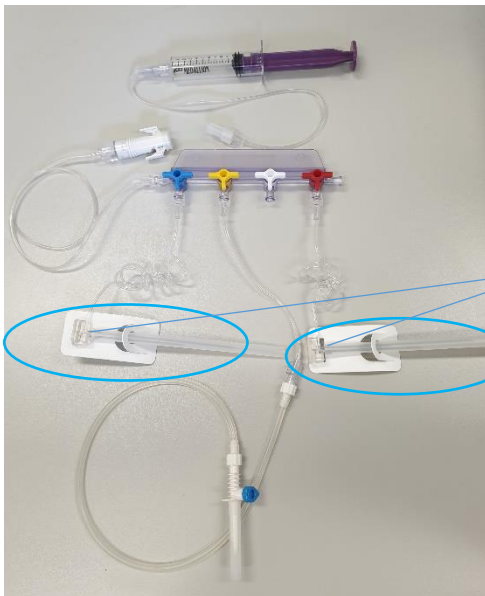
Batch KIT IRIS content:

Suspected Needle assemblies

We are working with our supply chain to have sufficient stock to replace all stock in the market, however, till then we advise you to check the presence of the filter before the use of the kit in 100% of the cases. To prevent unintended use of needles without the filter we sent you this notification with the request to check the 2 needle sets before using them in the IRIS. For selection you can use the below photos as reference:

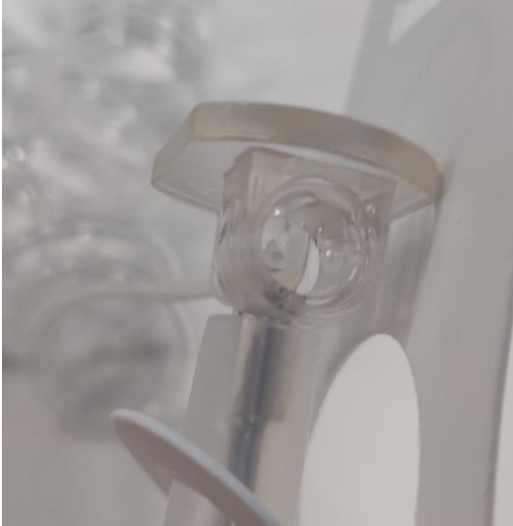
NOT GOOD

It has come to our attention that in Batch KIT IRIS a problem has been recognized. The problem concerns the missing of a Filter in the base of the needle for the Bulk vial and/or the waste vial.

Due to the missing filter the sterility of the Radiopharmaceutical in the bulk vial can be compromised.

In these needle assemblies we can see a white filter as below:

**NOT GOOD** and **GOOD** situation.

If you find any anomalies in your product, do not use that specific needle/kit.

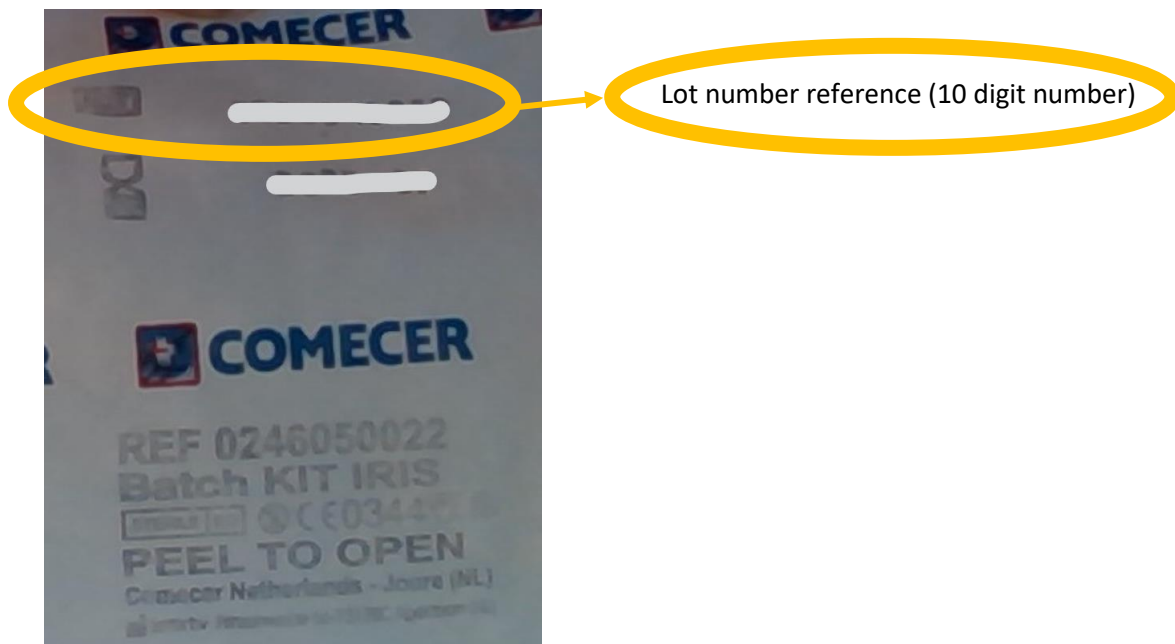
For this we kindly ask you to let us know the batch information as printed on the sterile packaging of the main kit. It concerns batches that were produced up to and including week 27-2021, which can be recognized by the first 4 digits of the batch number, for example 2721XXXXXX.
