URGENT Field Safety Notice

M5071A (adult) and M5072A (infant/child) pads for use with HS1/OnSite/Home AEDs may experience gel separation and reduction of gel surface area

22-FEB-2022

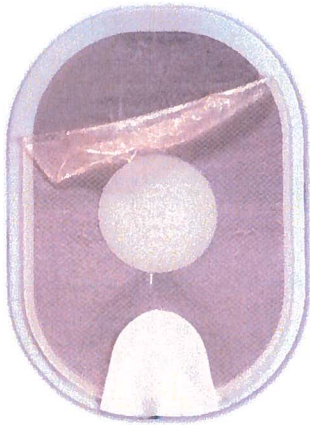
When a pad with separated, folded gel is placed on the patient's bare skin, the HS1/OnSite/Home AED could deliver less effective or ineffective therapy to the patient due to the reduced surface contact area with the skin. See example picture in **Figure 1**.

Figure 1: Separated gel that has folded onto itself when peeled.

Action:
Apply pads to the patient.
Do not hesitate.

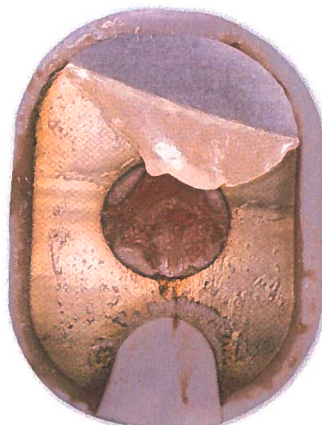
Separated, folded gel may also have a discolored and/or melted appearance. While the gel may also have a discolored and/or melted appearance, the appearance does not have any impact on the delivery of therapy;

however, there may be a delay in therapy if the user hesitates to apply the pad due to its appearance, and the AED may deliver less effective or ineffective therapy to the patient due to the reduced contact area with the skin. See example picture in **Figure 2**.

Figure 2: Separated, folded gel may also have a discolored and/or melted appearance.

Action:
Apply pads to the patient.
Do not hesitate.

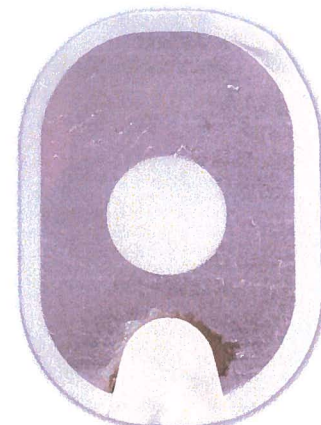
It is also possible that the gel could separate almost completely from the foam/tin backing when peeled, (see **Figure 3**.) Due to a small amount of gel surface contact area with the skin, electrical arcing could occur when a shock is delivered leading to burns to the patient's skin, or the AED could be unable to deliver any shock through the pads. A delay in therapy will result while the user installs a replacement pads cartridge (if available) or performs CPR while waiting for Emergency Medical Services Personnel to arrive. For comparison, **Figure 4** shows a normal pad. No matter the state of the pad, follow the voice prompts because the AED will step you through the necessary actions.

Figure 3: Gel almost completely separated from backing.

Action:
Replace pads cartridge if a spare is available. If no spare is available, perform CPR until help arrives.

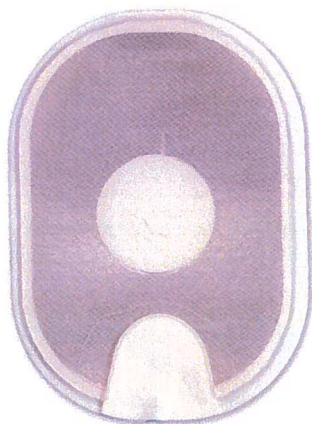
Figure 4: Normal pad. ✓

Action:
Apply pads to the patient according to the Instructions for Use/Owner's Manual.
