URGENT Field Safety Notification

Tempus Pro Monitor
Unexpected Device Error When Used With Tempus Pro Video Laryngoscope

06-NOV-2023

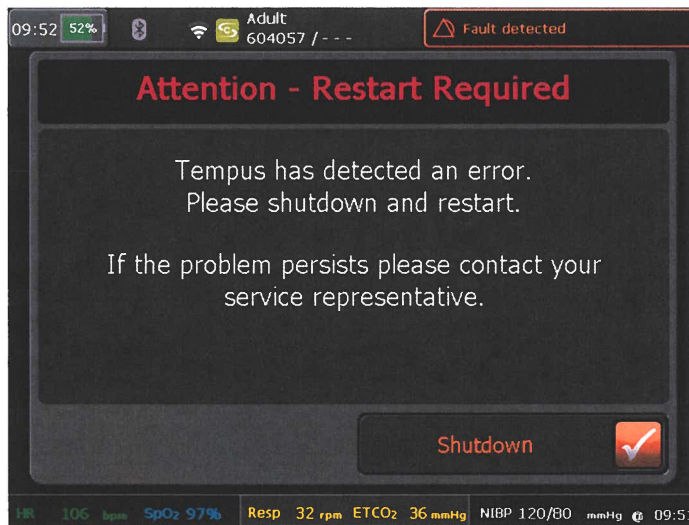
An issue has been identified with the Tempus Pro Monitor where an error may occur during video laryngoscope use with the Tempus Pro Video Laryngoscope or immediately after the Tempus Pro Video Laryngoscope has been unplugged from the Tempus Pro Monitor. If this error occurs, the user is presented with an unexpected full screen message informing the user an error has occurred, requiring shutdown and restart of the Tempus Pro Monitor. This full screen message prevents the user from viewing any graphical representation of patient vital signs; however, text and numerical values are still visible on the device's display screen. A visual of the message is shown below:

If this error occurs, the patient pulse tone (audio) that reflects the patient's level of oxygen saturation is no longer sounded and there will be no additional patient or device alarm LEDs or audio alarms while the error message is displayed. Additionally, the user will no longer be able to visualize the airway requiring the user to either intubate the patient without video imaging or use an alternative

laryngoscope not connected to the Tempus Pro Monitor. This message cannot be cleared from the Tempus Pro Monitor's screen and most of the monitoring functions are not available until the user initiates a complete shut down and restart of the device, which may take 60-100 seconds.

- When you receive the updated software solution from Philips, please install the software (V07.34) on your Tempus Pro Monitor according to the installation instructions provided. Once updated, you may resume use of the Tempus Pro Video Laryngoscope if you had removed it from service.

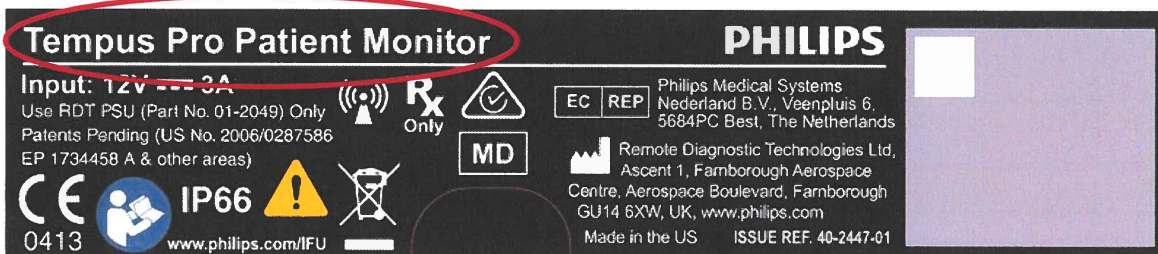
This correction directly affects Tempus Pro Monitors with Part Numbers 00-1004-R, 00-1007-R, 00-1024-R, and 00-1026-R with Trizeps-7 hardware, software v07.26 through v07.30, while using the Tempus Pro Video Laryngoscope with Part Number 01-2044. While Tempus Pro Monitors with Part Numbers 00-1004 and 00-1007 are not directly affected, these devices may have their hardware updated to Trizeps-7 hardware so are being included in this correction as a precaution. Tempus Pro Monitors are identified by a label placed on the rear of the device. An example is shown below:

The product number (REF) and Serial Number (SN) are printed in the gray box.

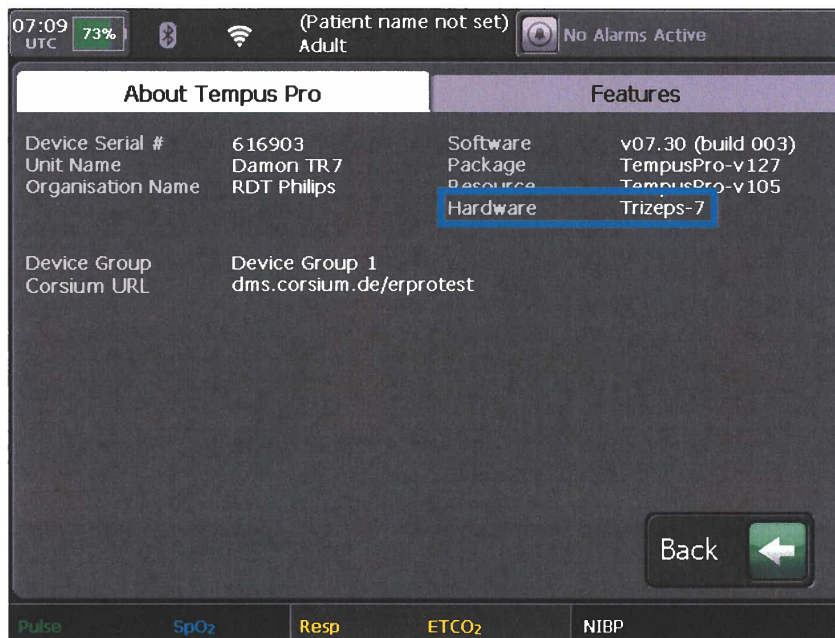
4. Identify the Hardware Version (Trizeps-7 or Trizeps-6)

- If the Tempus Pro Monitor has **Trizeps-7** Hardware, remove the Tempus Pro Video Laryngoscope from service with this monitor. Users must use an alternative laryngoscope not connected to the Tempus Pro Monitor to manage the patient's airway to avoid interruption in patient care. The Tempus Pro Monitor can remain in service if the Tempus Pro Video Laryngoscope is not connected to the monitor.

- If the Tempus Pro Monitor has **Trizeps-6** Hardware, the Tempus Pro Video Laryngoscope can continue to be used with the monitor.
- Post this Urgent Field Safety Notification letter on or near your Tempus Pro device.
