URGENT FIELD SAFETY NOTICE
IMPORTANT SAFETY INFORMATION

SAFETY NOTICE (FSN)
CONCERNING
Quality Flowmeter Serie

| MANUFACTURER INFORMATION | |
|---|--|
| Product / Device Name | Quality Flowmeter Series |

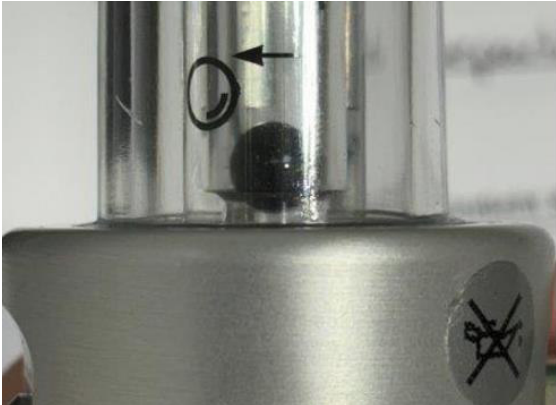
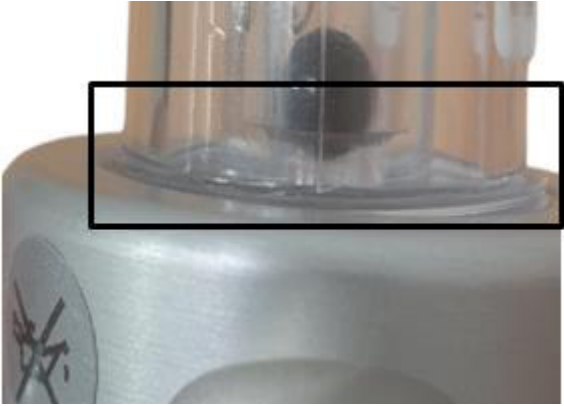
Our investigations, along with seven reported field incidents, have revealed that the top tube of the flowmeter may become loose during operation due to improper handling, particularly with repeated disassembly and reassembly. This issue may occur if the top tube is removed, for instance, for cleaning or disinfection purposes, and not correctly reattached. Such handling can cause damage to the thread, increasing the likelihood of leaks. These damages include noticeable wear (cross-threading) and potential cracking of the top tube’s thread. In addition to the sudden detachment of the top tube during operation, this can lead to product leaks, as there is an O-ring between the top tube and the flowmeter body that ensures tightness through compression at the connection point. Repeated disassembly and reassembly can cause the O-ring to shift, resulting in leaks.

| Step | Action | Description |
|---|---|--|
| 3 | Visual Inspection of Correct top tube Assembly | <p style="text-align: center;">Correct: The top tube is properly inserted into the base.</p> <p style="text-align: center;">Incorrect: The top tube is either tilted in the base or dislodged due to a severe impact or fall (see marked area).</p> |

Inspect the products for the connection point between the top tube and the flowmeter body. If you detect any leaks, damage to the product, or notice that the top tube is not correctly mounted, immediately contact a technician or service representative. Do not continue to use the affected flowmeter until it has been serviced or repaired by authorized personnel.

The thread and associated connection of the top tube to the flowmeter body will be redesigned. The thread pitch and size will be changed (from fine to coarse thread) to prevent damage due to improper assembly and to ensure any tampering is immediately detectable. Additionally, the flowmeter instructions for use have been updated to revision 2.0, including additional information regarding the intended safe use and inspection of the product.
