**Date:** January 2025

**Urgent: Field Safety Notice - Initial**  
**Dexcom G6 Receiver – FAS-SD-24-003 - US-MF-000010694**

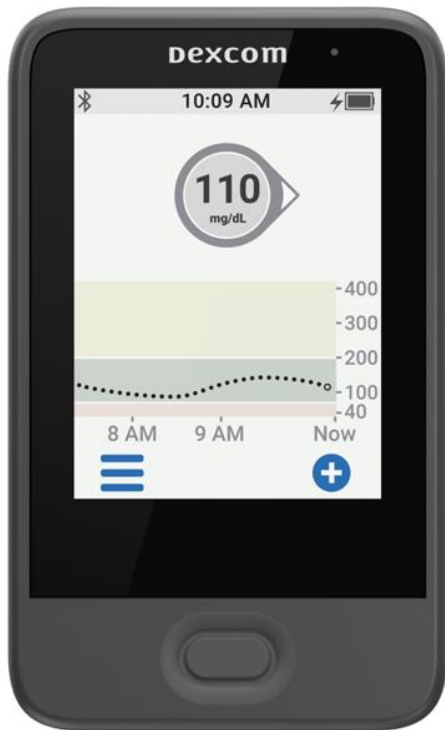
**Front of Receiver  
Example Rendering:**

The part number is listed on the back of the receiver as shown in the image to the right/below:

**Note:** If your receiver does not look like the images above and has a different part number, then it is not affected.
