Urgent Field Safety Notice

Welch Allyn Connex Vital Signs Monitor (CVSM), CP150 Electrocardiograph & Connex Spot Monitor Accessory Power Management Stand (APM)

Field Action Reference: FA-2025-009

Manufacturer: Welch Allyn, Inc. (Single Registration Number: US-MF-000013394)

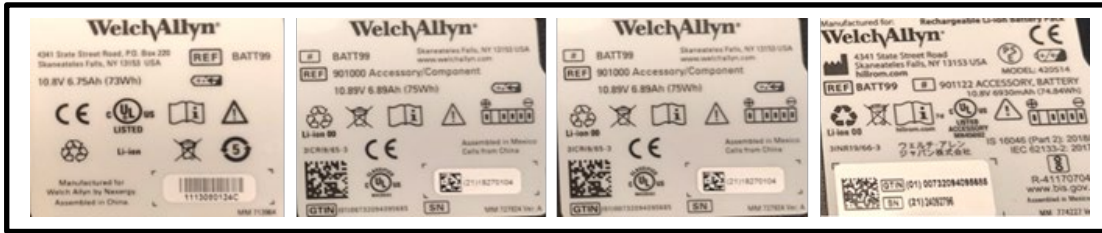
Figure 1: Examples of Label for Approved Batteries

1. **DO NOT USE UNAPPROVED BATTERIES.** Baxter asks customers to only use the approved Baxter / **Welch Allyn** BATT99 battery, consistent with product labeling due to their safety and performance testing.
2. **INSPECT ALL DEVICES.** If you have a device identified in the affected product table above, check the device for the correct battery type. See Figure 1 below for examples of labels from approved batteries labelled with the BATT99 product code, "Welch Allyn", and the Skaneateles Falls manufacturing facility address.

3. STOP USING THE DEVICE if an unapproved battery is found.
4. IMMEDIATELY REPLACE THE UNAPPROVED BATTERY with an approved battery. Please contact your local Baxter sales representative to order the approved Baxter / Welch Allyn BATT99 batteries.
