URGENT FIELD SAFETY NOTICE

Medtronic Evolut™ PRO+/FX/FX+ Bioprosthesis

Potential Jar Lid Particulate - IFU Update

Medtronic Reference: FA1483

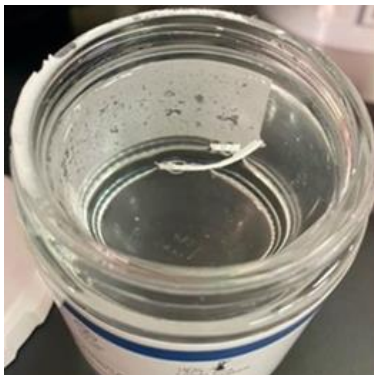
Medtronic has received reports of users having difficulty opening the jar, which may cause damage to the lid, resulting in the potential for particulate (see Figure 1) transferring from the lid to the jar containing the bioprosthesis. As of January 31, 2025, Medtronic has observed an incidence rate of 0.043% for this jar lid issue. To date, there has been no patient harm nor serious injury reported.

Figure 1. Example of Jar lid particulates

Medtronic has no evidence of seal degradation and no evidence that the sterility of the bioprosthesis is compromised. If particulate material is observed in the solution upon opening the jar, the bioprosthesis should be discarded and a new unopened device used instead. In accordance with current Instructions for Use (IFU) and training, the bioprosthesis should always be rinsed with 3 rinsing bowls before use.

Medtronic is conducting a thorough investigation of the events, including manufacturing process mitigations. In the interim, Medtronic has initiated an action to update the applicable IFUs for Evolut PRO+/FX/FX+ as follows:

“Do not use the bioprosthesis if there is any damage to the container (for example, cracked jar or lid, leakage, particulate material, broken or missing seals or jar lid gasket).”
