Urgent Field Safety Notice (RECALL)

Guedel Airways

1. Information on Affected Devices*	
1.	1. Device Type(s)*
	Guedel Airway
1.	2. Commercial name(s)
	One-piece Guedel airway, size 2, ISO 8.0, green One-piece Guedel airway, size 3, ISO 9.0, yellow One-piece Guedel airway, green, ISO 8.0, size 2 (grouped in 10s) One-piece Guedel airway, yellow, ISO 9.0, size 3 (grouped in 10s)

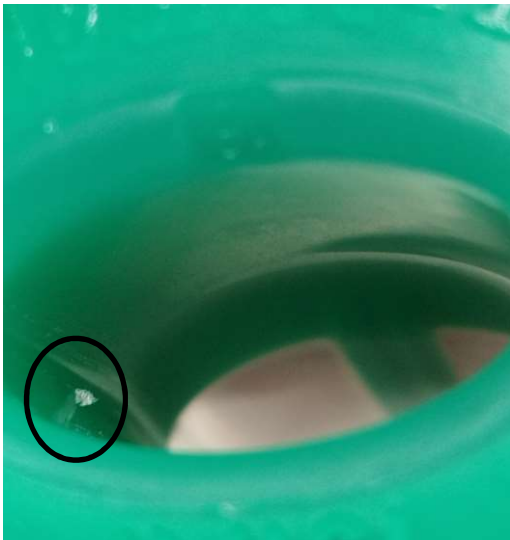
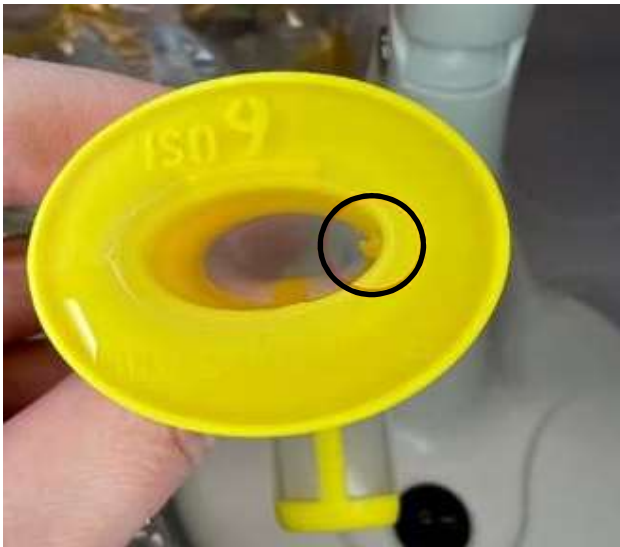
2. Reason for Field Safety Corrective Action (FSCA)*	
2.	1. Description of the product problem* During manufacture small plastic burrs have been identified inside the Guedel Airways, as shown below. <div style="display: flex; justify-content: space-around;">

2.	2. Hazard giving rise to the FSCA* The device is potentially contaminated with small plastic burrs inside the Guedel or packaging from the manufacturing process. If the burr becomes detached and is inhaled, it could result in potential complications such as airway obstruction, tissue irritation, inflammation and infection.

2.	6. Background on Issue A non-conformance was raised for plastic burrs found inside the Guedel Airway during manufacture. The fault was caused by damaged production equipment contacting the inside of the Guedel Airway, which has since been corrected with no further problems identified. Further evaluation of products and manufacturing records has enabled us to confirm the range of products and lot numbers under this FSCA. No reports of this problem have been reported from the market to-date.

2.	7. Other information relevant to FSCA N/A	
3. Type of Action to mitigate the risk*		
3.	1. Action To Be Taken by the User* <div style="display: flex; justify-content: space-between; margin-top: 10px;"> <input checked="" type="checkbox"/> Identify Device <input checked="" type="checkbox"/> Quarantine Device <input checked="" type="checkbox"/> Return Device <input type="checkbox"/> Destroy Device </div> <div style="margin-top: 10px;"> <input type="checkbox"/> On-site device modification/inspection <input type="checkbox"/> Follow patient management recommendations <input type="checkbox"/> Take note of amendment/reinforcement of Instructions For Use (IFU) <input checked="" type="checkbox"/> Other <input type="checkbox"/> None </div> <p>Please distribute this Field Safety Notice to all potential users of the Guedel Airway devices listed above, within your facility. This is for their awareness of the potential problem and to carry out the following actions.</p> <ol style="list-style-type: none"> 1. Identify and immediately quarantine any potentially affected products from the affected code and lot numbers listed above. 2. Please complete the Reply Form below to confirm the products you have identified, to arrange collection of the devices and a credit. 3. If you have no affected devices in stock, please confirm this using the Reply Form below. 4. Please return the Reply Form provided below to giedriusb@intersurgical.it, to confirm receipt of this notice and that the necessary actions have been taken. <p>Please note: This is a Recall.</p> <p>Please continue to report to Intersurgical any adverse events involving this product.</p>
