Urgent field safety notice Easymoov6 Enteral feeding pump

Urgent Field Safety Notice (FSN) Easymoov6 Enteral feeding pump Risk addressed by FSN

Appendix 1 : Reminder on tubing installation on Eaymoov6 enteral feeding pumps

Appendix 2 : Security added to the cover

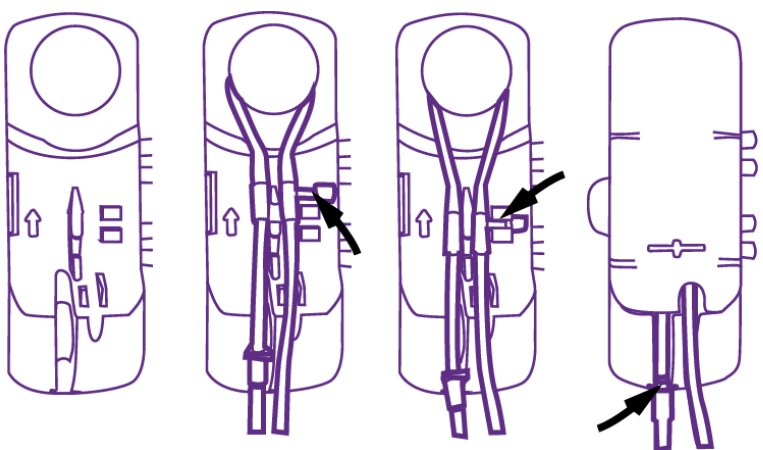
(1) Open Easymoov6 pump cover.

(2) Place the silicone loop around the rotor and make sure the cassette is in the right direction.	
(3) Push the cassette in the middle of the pins with your thumb and make sure the cassette is well positioned between the two black pins. Guide both tubes down, in line with their respective slots.	
(4) Close the pump cover, then place the adapter into the designated slot.	
Remove the protective cap from the tubing.	
Launch automatic priming (see section 3.5).	<div>(1)</div> <div>(2)</div> <div>(3)</div> <div>(4)</div>
Connect the tubing to the patient enteral feeding tube and program the pump.

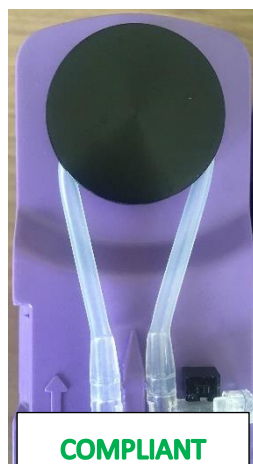
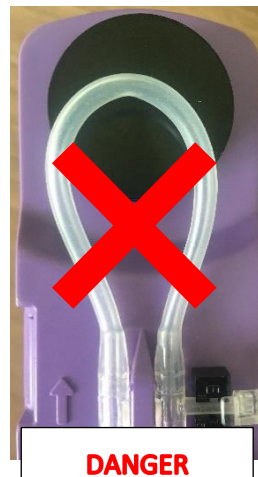
- **not to connect the tubing to the probe** before priming,
- **to check the correct position of the silicone tube** around the rotor:

2 Reason for safety corrective action in the field (FSCA)* (in English)	
2	1. Product problem description
	Medwin was informed of an incident in a healthcare facility. The user failed to place the silicone tubing around the rotor, resulting in a significant overflow.
2	2. Risks behind the FSCA
	Risk of overflow and free flow
2	3. Probability of a problem occurring
