**URGENT Field Safety Notice**

Tempus Pro Monitor  
Intracranial Pressure (ICP) and Bladder Pressure (BDR) Pressures May be Inaccurate

25-NOV-2025

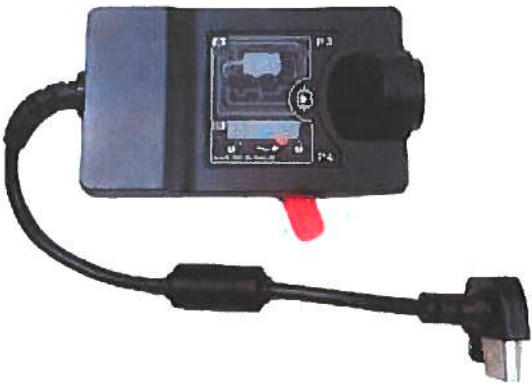
A picture of the external USB 2-Channel IBP Module is below; this module is identified by a label with the part number.

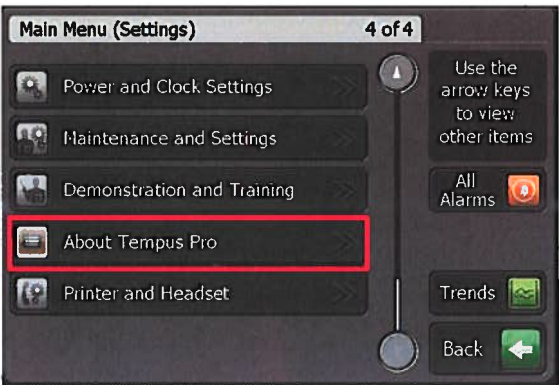
1. Select “About Tempus Pro” from main menu.

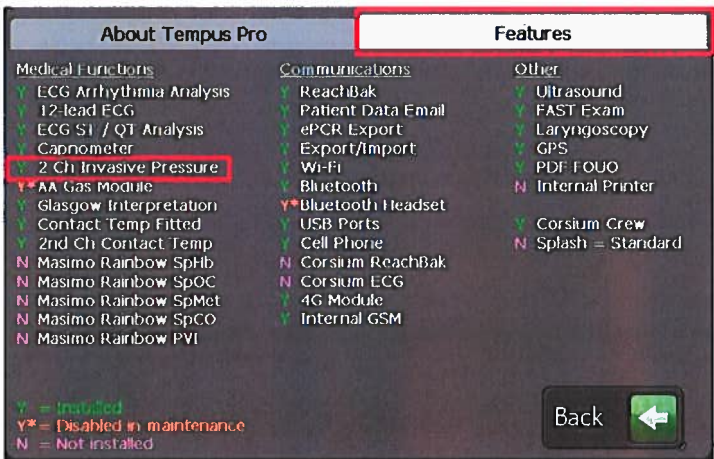
2. Select “Features” tab.

3. If “2 Ch Invasive Pressure” is “Y” then your device has IBP enabled.
4. If “2 Ch Invasive Pressure” is “N” then your device does not have IBP enabled.
