Urgent Field Safety Notice

PRISMAFLEX SETS, OXIRIS SETS (to be adapted locally)

FA Number: FAV-2025-010

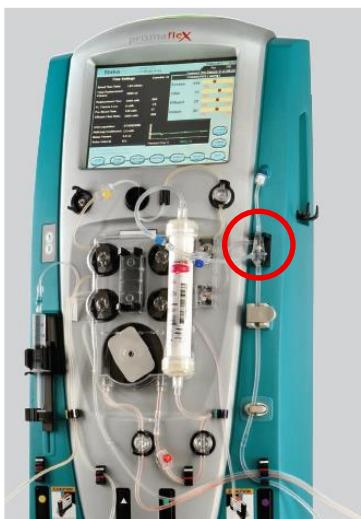
Fig 1: Prismaflex chamber holder

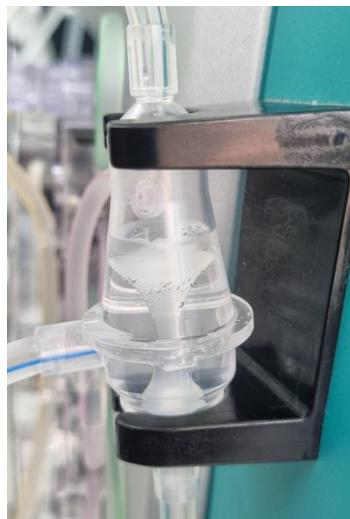
Fig 2: Secure deaeration chamber in holder

- You may continue to perform therapy using the Prismaflex sets listed above.** Please monitor the deaeration chamber during therapy to ensure it remains in an upright position within the holder.
- Vantive is aware of customers who have experienced this issue and attempted to further secure the deaeration chamber in an upright position. If attempting to secure the deaeration chamber in an upright position, please consider the following:
 - Ensure there are no kinks in the tubing and that the deaeration chamber remains visible.
 - If the **Prismaflex** Control Unit issues an “Air in Blood” alarm, check if air is present. If there is no air present, check if the deaeration chamber is dislodged from the holder and ensure there are no clots present.
 - If no dislodgement, please follow the operator’s manual instructions for “Air in Blood” alarm.

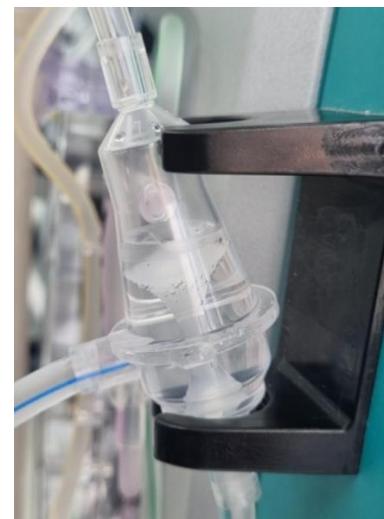
Vantive is issuing a Correction to all Prismaflex Control Unit users due to the potential dislodgement of the Prismaflex Set deaeration chamber from the Prismaflex Control Unit, as shown in Figure 3 below. **This issue does not affect PrisMax Control Units and may occur only when the Prismaflex Sets are being used with the Prismaflex Control Unit**, as the two machines have different deaeration chamber holder designs.

Fig 3: Dislodged deaeration chamber in holder

A dislodged deaeration chamber may lead to an “Air in Blood” alarm on the **Prismaflex** Control Unit. The alarm may occur during the priming phase prior to initiating therapy, or during therapy—resulting in a delay/interruption of therapy, and in some cases blood loss due to clotting/failure to return blood manually. Vantive has not received any reports of serious patient injury related to this issue.

2. In case of dislodgement with clotting, follow the associated instructions within the **Prismaflex** Control Unit operator's manual to stop the therapy and replace the set.

3. Only in case of dislodgement without clotting or any other alarms, if the chamber is secured in an upright position, follow the associated instructions within the **Prismaflex** Control Unit operator's manual to proceed with treatment.
