**Medical device field action**

**HeartSine® samaritan® PAD**

**SAM 350P/SAM 360P/SAM 450P/SAM 500P**

**Field action number: PR4280335 – FA319**

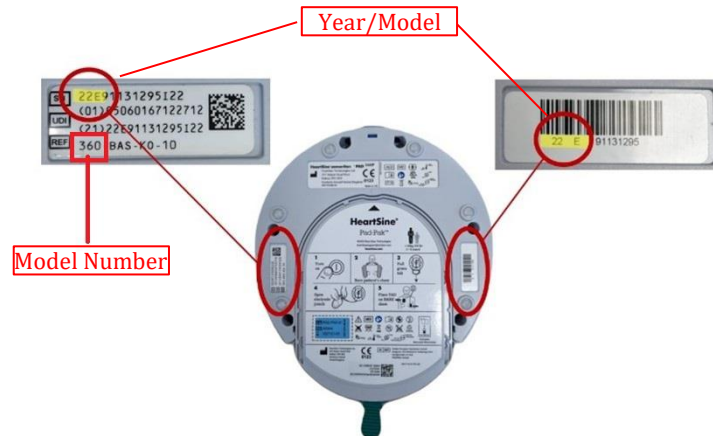
*Figure 1 – Serial & Model Number location*

- 1) To find your device serial number and model number, see the labels on the rear of your device as shown below:
