October X, 2018
Olympus reference: QIL 151-006

URGENT FIELD SAFETY NOTICE

Model Name	
Olympus Airway Mobilescope	MAF-TM	All Serial Numbers
Ultrasonic Bronchofiberscope	BF-UM40	
Ultrasonic Bronchofibervideoscope	BF-UC160F-OL8, BF-UC180F, BF-UC260FW ,BF-UC260F-OL8	
Bronchofiberscope	BF-XP40,BF-3C40, BF-P40, BF-40, BF-1T40, BF-XT40, BF-XP60, BF-MP60, BF-P60, BF-1T60	
Bronchovideoscope	BF-XP160F, BF-3C160, BF-MP160F, BF-P160, BF-160, BF-1T160, BF-XT160, BF-P180, BF-Q180-AC, BF-Q180, BF-1T180, BF-1TQ180, BF-P240, BF-240, BF-6C240, BF-1T240, BF-1T150, BF-P150, BF-260, BF-1T260, BF-6C260, BF-P260F, BF-XP260F, BF-F260,	
Rhino-Laryngo Videoscope	ENF-VT, ENF-VT2

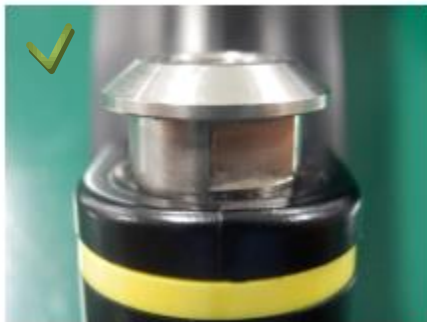
Picture 02: Normal Condition

Visually inspect the rubber part around the biopsy port of the referenced endoscope. If the rubber part is in a normal condition as shown in picture 02, the endoscope can be used in a patient procedure. If the rubber part is lifted from the molding parts as shown in picture 03, do not use the endoscope and return it to Olympus for repair.
